## Memorandum

**Date:** August 8, 2023

**RE:** **Arborist Report**  
**Adobe Road and Main Street Intersection Improvement Project**  
**Penngrove, Sonoma County, California**

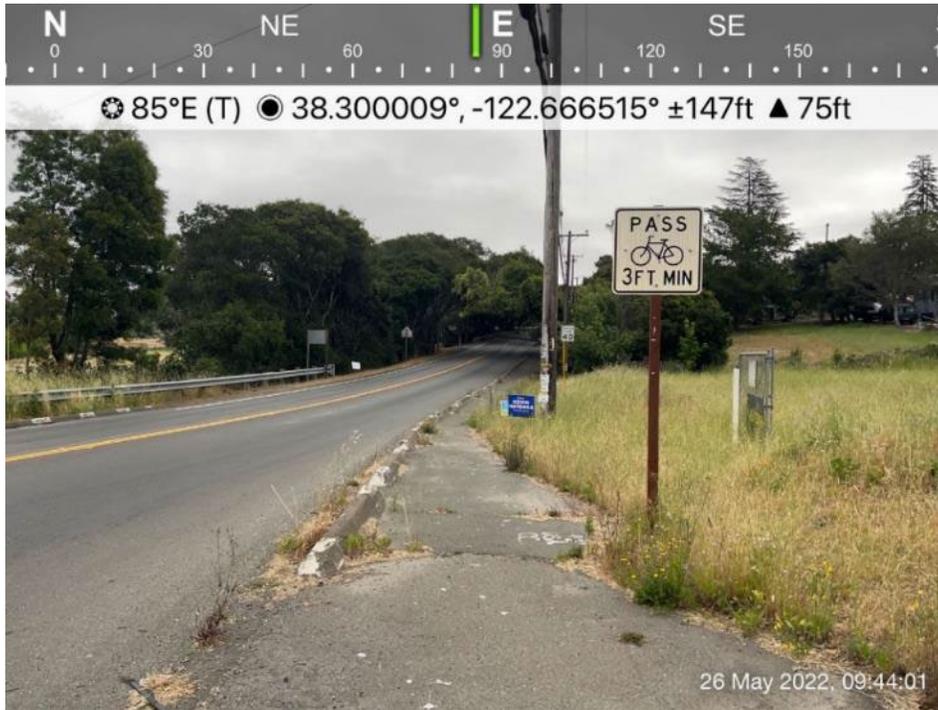
**Photograph 1.** View of dense stands of coast live oaks located along each side of Adobe Road east of intersection with Main Street.

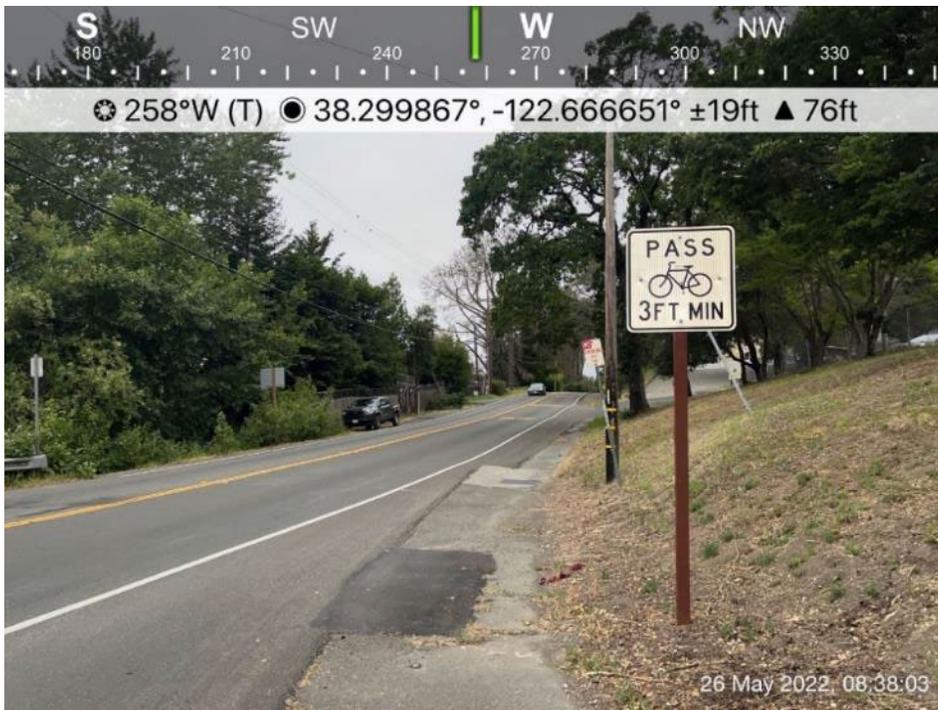
**Photograph 2.** View of row of trees along school property on Adobe Road west of intersection with Main Street.

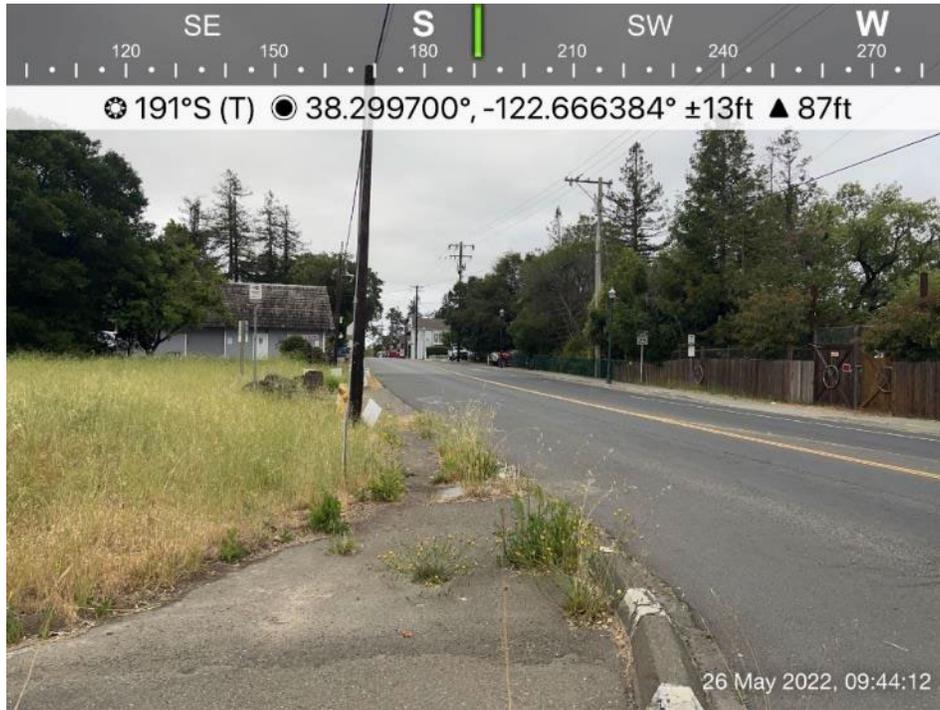
**Photograph 3.** View of Main Street facing south of intersection with Adobe Road.

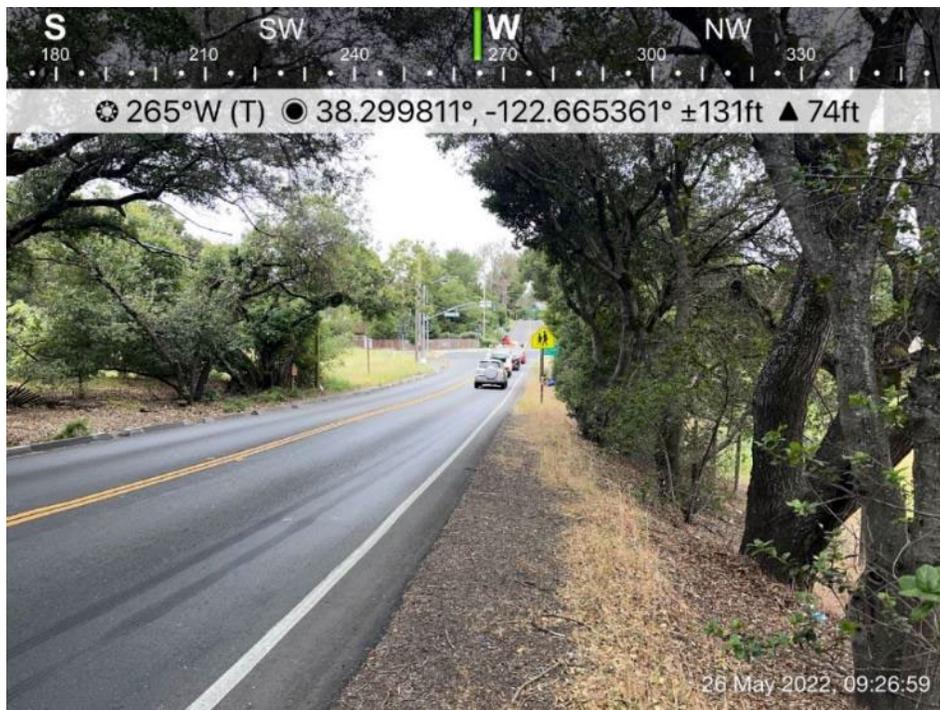
**Photograph 4.** View of stands of coast live oak and California live oak along Adobe Road east of intersection with Main Street.
