Revisions to the scope of work enhance the previously-approved Development Plan for improvements proposed at 18285 Sonoma Highway, Sonoma, CA 95476, aka *Boyes Springs Food Center Mixed-Use Redevelopment*.

# DESIGN REVIEW COMMITTEE RECORD OF ACTION

Re: Tree report for Boys Food Center, 18285 Sonoma Hwy, Sonoma, CA.

# Tree Location Map

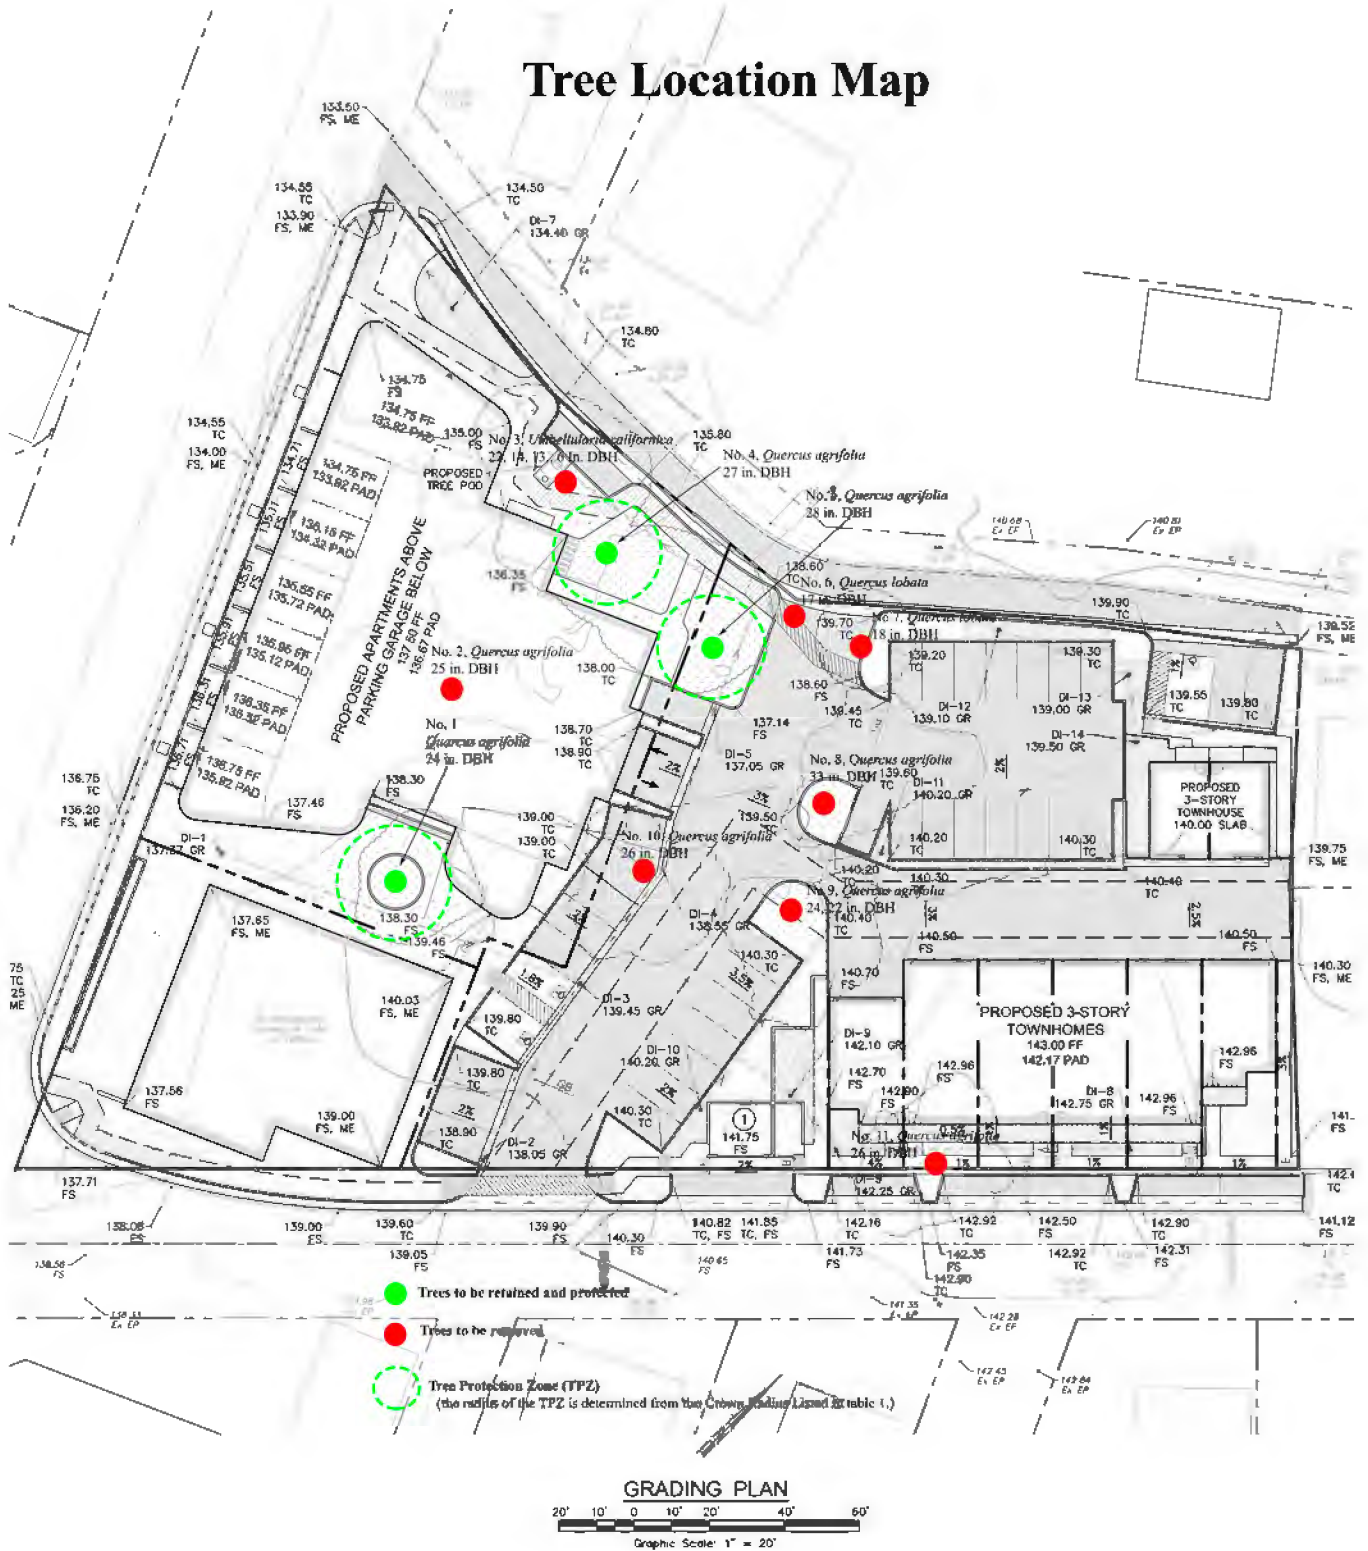
- **Tree No. 2**, a California Coast Live Oak, has trunk decay and other defects that will likely cause failure. This is a poor candidate for retention

- **Tree No. 3**, a California Bay, has four trunks arising from its base with a potentially weak structure. Bay trees are also prone to root decay, particularly from *Ganoderma applanatum* a serious root and trunk decay fungi. Additionally, California Bay is the reservoir of Sudden Oak Death (SOD) a fungus that affects California Coast Live Oak, the dominant species on the site.

- **Tree No. 6** is a Valley Oak and a Protected Species of Special Significance. This particular tree has lost more than half of its top that was broken at a height of about 15 feet. I don't consider this tree an acceptable specimen for retention.

- **Tree No. 9**, a California Coast Live Oak, shows evidence of upper crown thinning. This could be the result of paving around half its root system, drought, root disease, or a combination of all three. This tree should not be considered for retention.

The Tree Location Map page 4 shows the location and disposition of trees within the proposed grading plan. Because the property is planned as a mixed use, high density development, the opportunity to retain

Within the current site plan, tree's Number 1, 4, and 5 have sufficient room to be protected. The map on page 4 shows the location of each tree and the delineation of the recommended Tree Protection Zone (TPZ). The TPZ's are based on the crown radius measured from the trunk to the most distant point at the edge of the dripline. That radius is then used to form a circle around the trunk. These three trees present the best opportunity for preservation. With some minor adjustment there is sufficient room for these trees to successfully be preserved.

**Tree No. 1:** The proposed well around the trunk needs to be enlarged to more closely match the TPZ. Alternatively, a combination of well enlargement and porous pavers with alternative curbing B (page 6) can be used to accomplish this. As an alternative, to traditional curb detailing, the paving surface can be installed first with anchor stakes to which either treated lumber, or a second concrete pour can be attached.

**Tree No. 4:** Some minor adjustments in the location of the sidewalk would be beneficial, however, hand trenching for footings along the south edge with root pruning should result in minimal impact to tree health. This same recommendation can be applied in the area where the building foundation encroaches into the west side of the TPZ.

**Tree No. 5:** The current site plan shows very minimal encroachment of pavement at the edges of the TPZ. There is a proposed 6 inch SD pipe that will go through the TPZ and if it remains at that location, special mitigations will be required. The Sonoma County Tree Protection Ordinance requires hand digging of trenches through TPZ's. I also recommend the use of either an air-spade or hydrovac to dig trenches through root zones. Both tools prevent damage to fine roots and those that are larger. Some root pruning may be required to fit the pipe below the roots. Root pruning should be kept to a minimum and avoid cutting any roots larger than 2 inches in diameter.
