Report on monumenting of Section Corners of a portion of T6-R10 & T7-R10, M D B & M, bounded on the west by the Bodega Rancho; on the south by the Rancho Estero Americano, and on the east by the Rancho Canada de Jonive and the Rancho El Moline.

Sheet 1.

A portion of T 6 & T 7 N, R 10 W, M D B & M
 Bounded on West by the Bodega Rancho;
 Bounded on South by Rancho Estero Americano;
 Bounded on East by Rancho Cahada de Jonive;

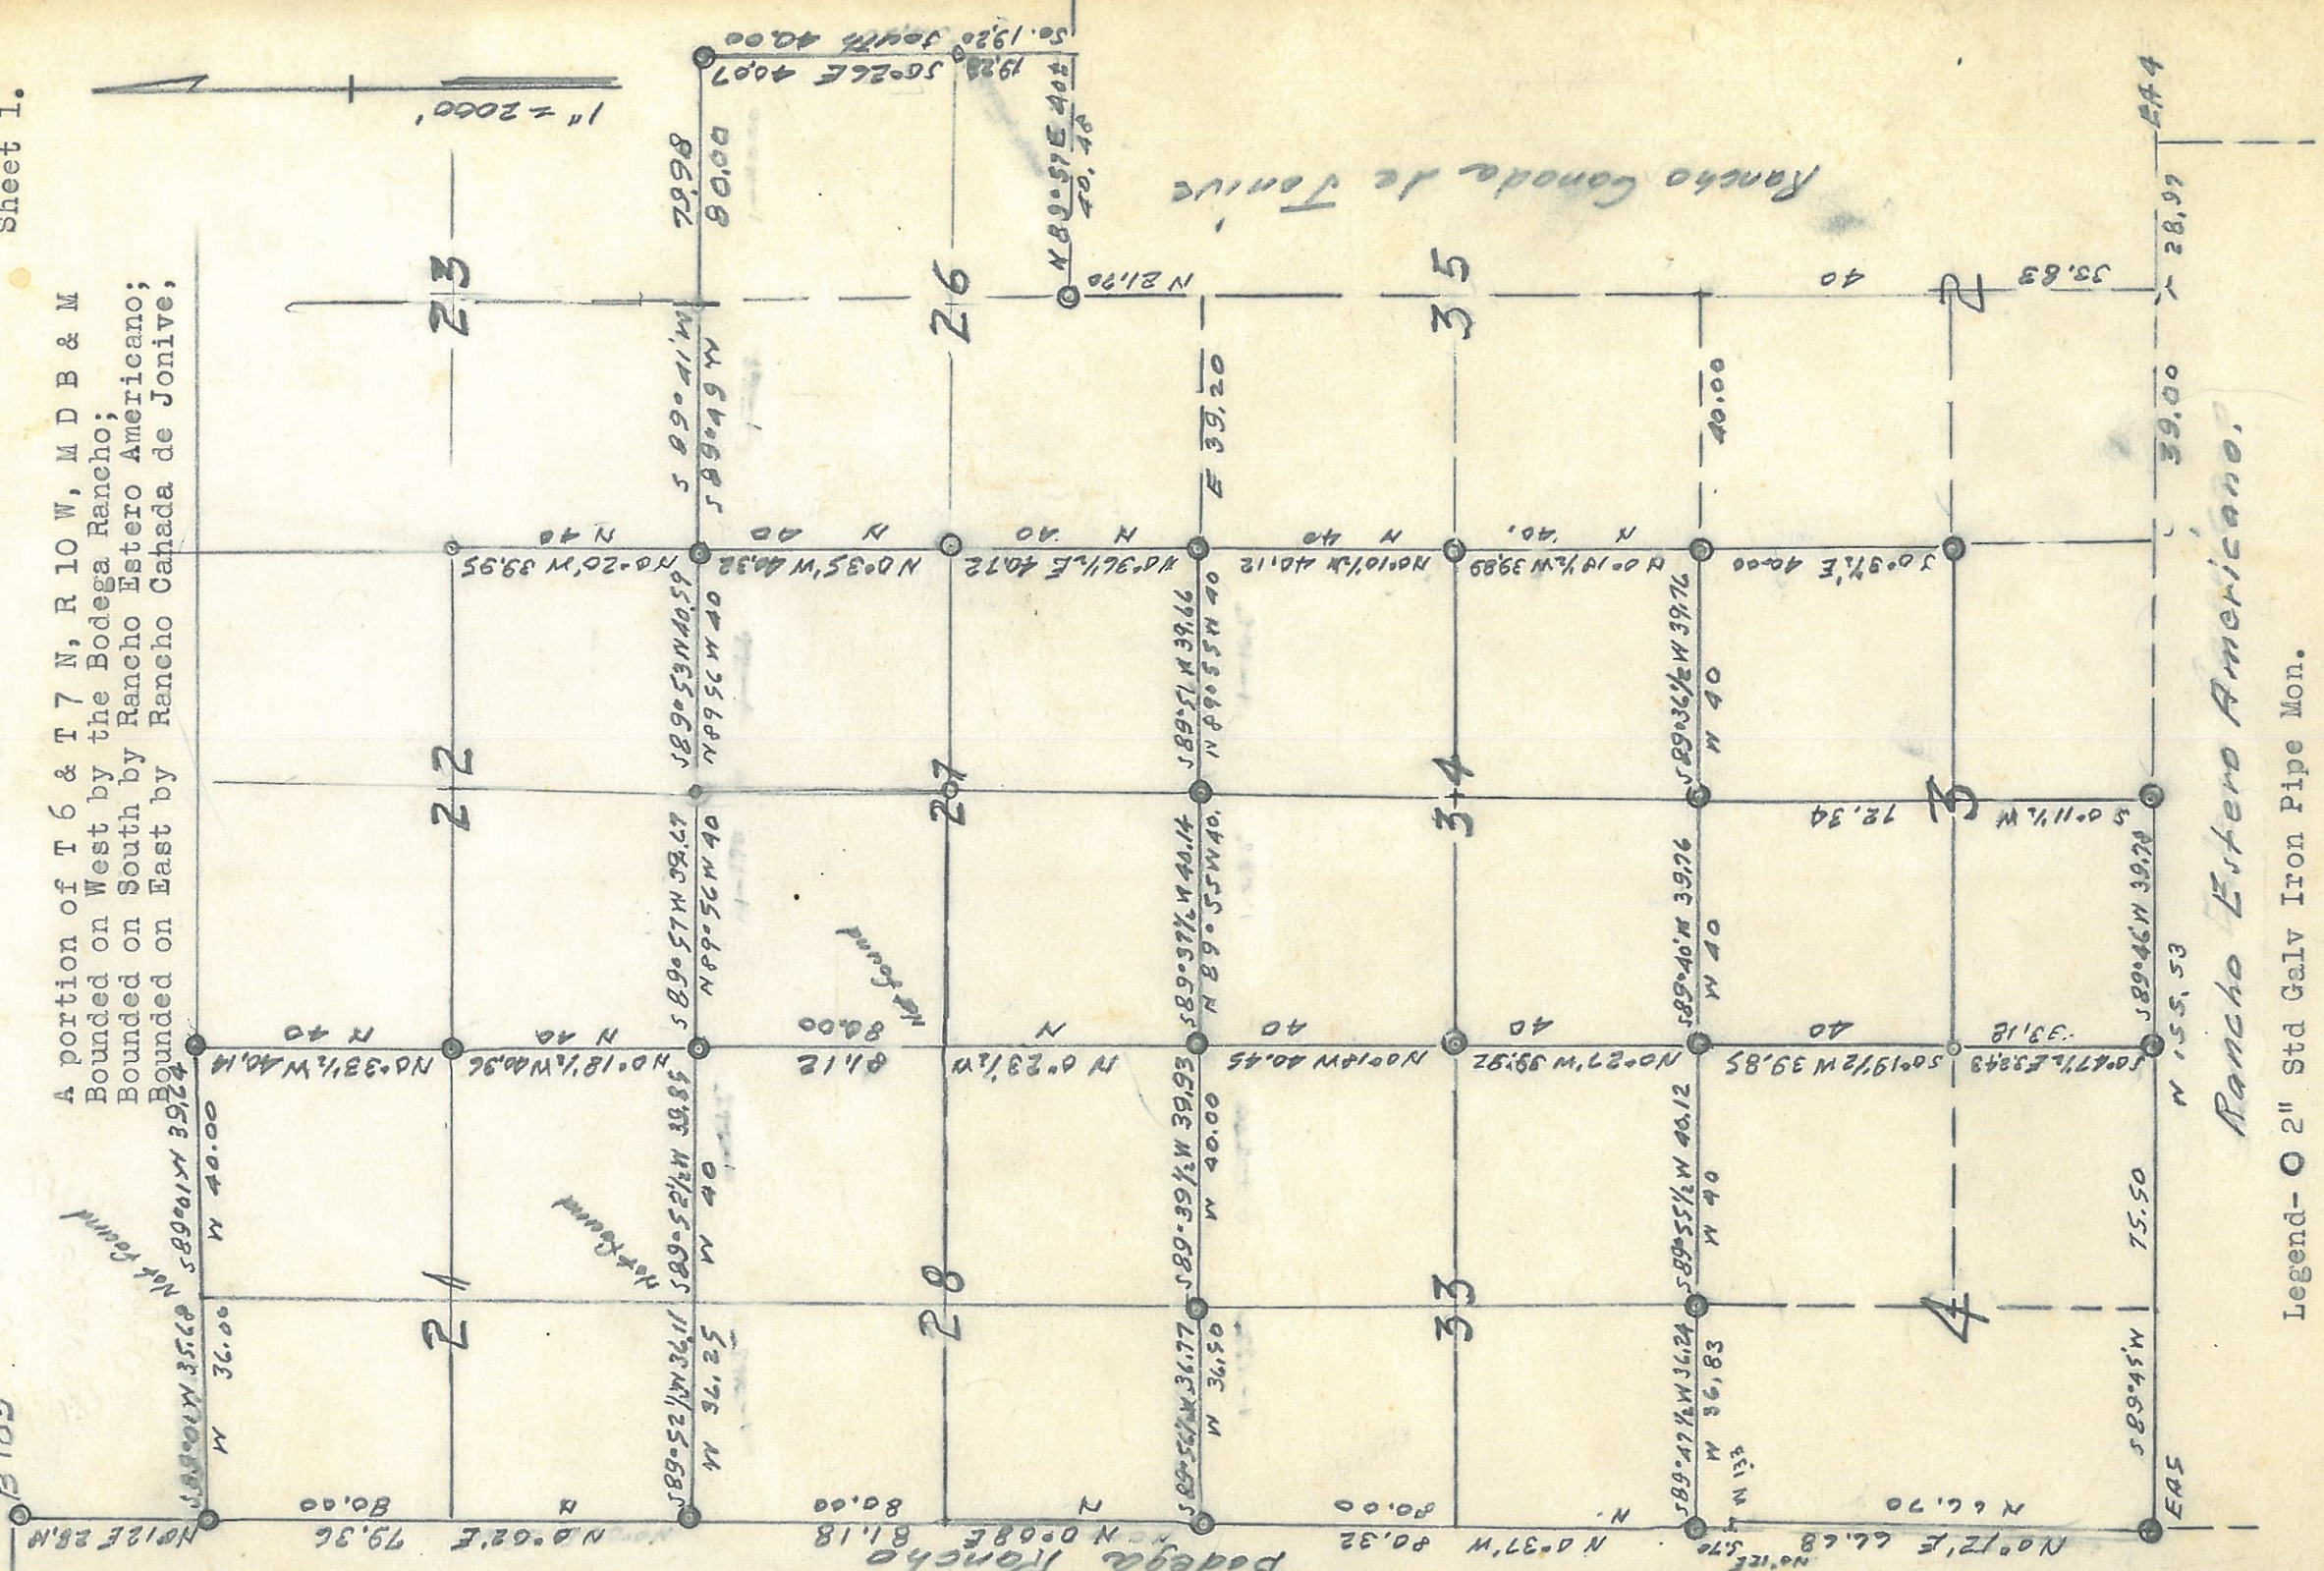
On Sheet 1 of the report is given above the line, bearings and distances as determined in surveys made 1941 to 1959, while below the line are these same courses as shown on photostats of the Government Records.

An inspection of the calls against the actual distances will show that there is no uniformity as to errors in distances. Call attention to an error of one chain in the east line of S 27, which was carried across the Township, from the El Moline to the Bodega Rancho line.

Also it should be noted that the bearings between corners are uniformly about 4° out to the NW and to the S W. If Wahl had used 16°45' on the Subdivision, as he did on the retrace of the Bodega Rancho line, instead of 17°00' as he did, the lines would have been closer to normal.

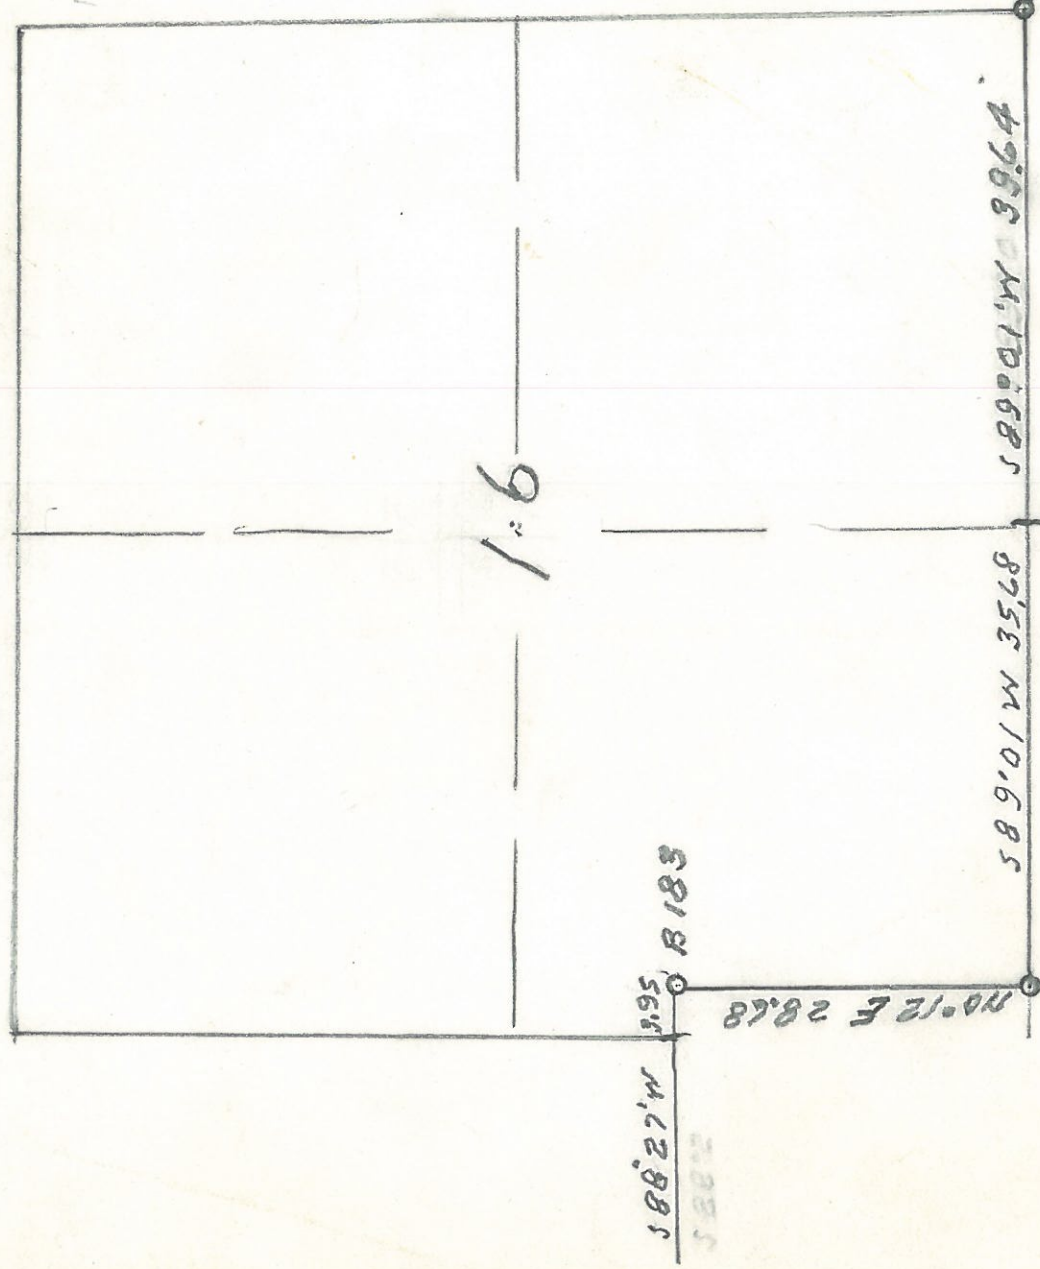
Sec 16, T 7 N, R 10 W, M D B & M.

After exhaustive search, found the northeast corner of the Bodega Rancho, a Redwood Stake marked B 183, in remains of a mound of stones, said stake being in a remarkably good state of preservation. Set Standard 2" I P in place of stake, which wired to pipe, and renewed mound of stones. On Barren hillside facing south, scattered brush and stunted trees, Stony porous ground, explaining preservation of stake. Located this point by triangulation from point above old NWP railroad tunnel. Used double base at B 183, as check on distance.

Frac Cor Sec 16-17 on BO Ro Line, Diligent search failed to reveal any trace of BT's. Distance from B 183 to Frac 17-18 proportioned as per instructions Bureau of Lands Instructions.

Frac Cor Sec 16-21, on BO Ro Line. Attempted to locate from data on N W P Railroad Map, The point thus located did not answer calls for Redwood BT. as no redwoods this location. Worked south until spotted redwood, then set temporary corner, and from this located the Live Oak BT. Using these trees, located frac corner as per calls for bearing and distance.

Cor 16-15-21-22. Triangulated north from $\frac{1}{4}$ cor 21-22, to top ridge then east to calculated location; found well defined property fence corner, with fences north east and south. Diligent search failed to find BT's. Location answers calls for topog. under circumstances must accept as true corner. When later sent men to place Std I P. they found $1\frac{1}{2}$ " IP set probably by Walter Adams.

$\frac{1}{4}$ Cor Sec 16-21. Ran west from SE Cor, found remains old fence east & west, call for BT's two 4" live oaks (probably tan oaks) but exhaustive search failed to reveal any trace. Field notes show local variation of $\frac{1}{2}^{\circ}$ west and $1\frac{1}{2}^{\circ}$ east at points 15 chains apart, probably accounting for discrepancy in bearing of the line between Sec 16 and 21.

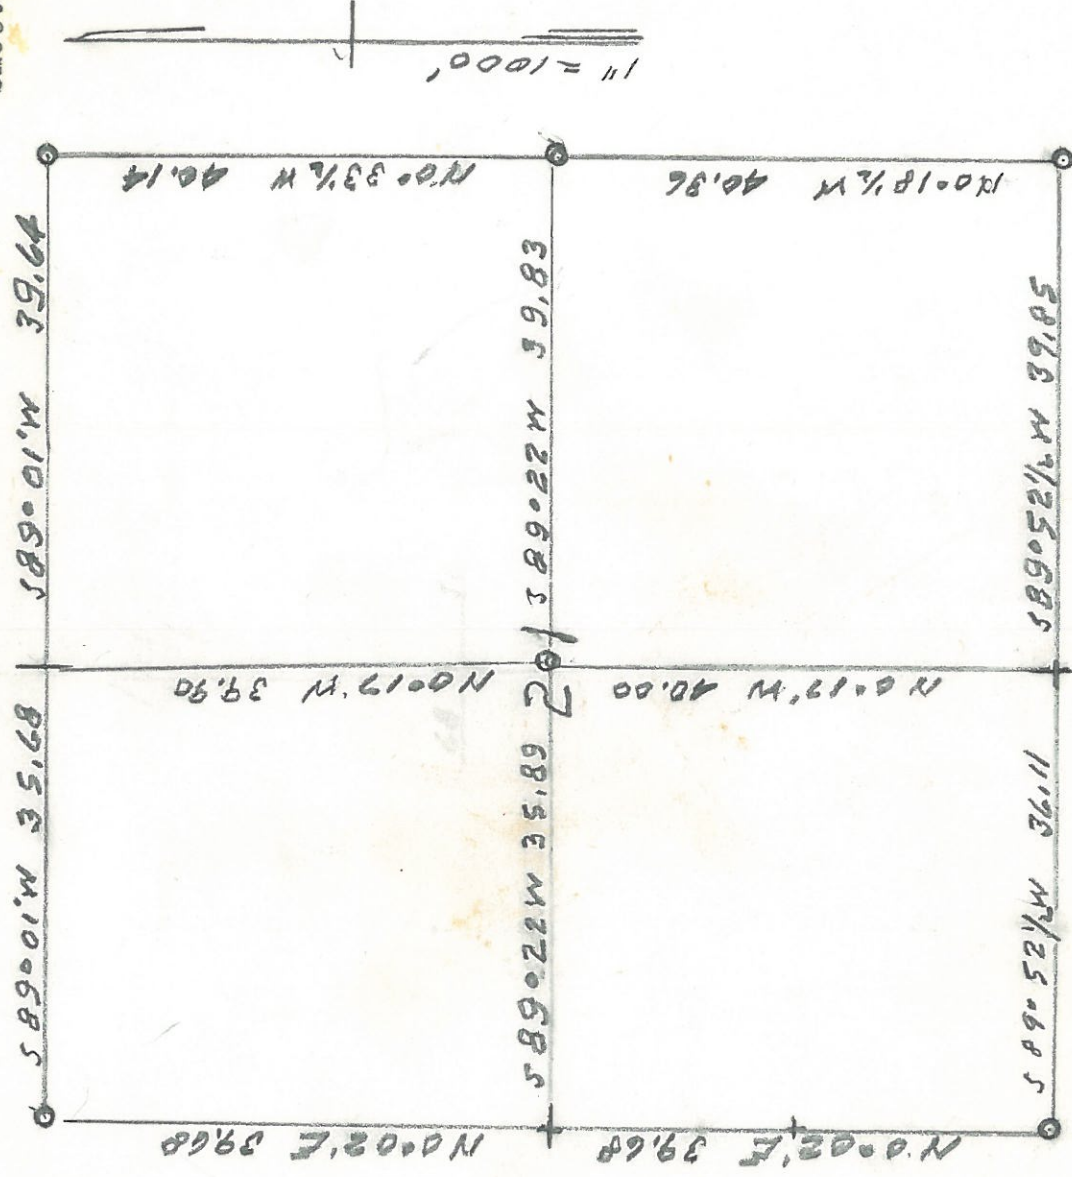
Sec 21, T 7 N, R 10 W, M D B & M.

Frac Cor Sec 21-28, on Bodega Rancho Line. In retracing East Line Bodega Rancho, after exhaustive search, found partly charred stake, on steep slope facing east; traced uphill until located suckers of destroyed Madrona; using this as guide, located remains of large oak, Set fractional corner on calls for these two BT's; calls for topog check as well as can be expected.

1/4 Cor Sec 21-28. Made two separate attempts to find this corner; Where call is for being set in opening, with two BT's, a live oak and a madrone, found only tan oak trees. Unable to locate either corner or remains of BT's. The calculated position used in locating center $\frac{1}{4}$ and $1/16$ corners, for property lines in this section. Check of calculated position of the Center $\frac{1}{4}$ corner, marked by a standard 2" IP, leads to belief that may be incorrectly placed. Remembrance is that saw an iron pipe mon. east of Mon set. Further checking is in order.

Cor Secs 21-22-27-28. Found Std 2" IP set by Ed Peugh; probably in 1920's; checks with calls in field notes.

1/4 Cor Secs 21-22. Found old stake at fence corner, probably set by Ed Peugh. Found both BT's which check for calls; In 1956 found 2" IP marked for corner 15-16-21-22, lying near the $\frac{1}{4}$ corner. Was never informed that due to incorrect marking, was never set.

My records show that a $1\frac{1}{4}$ " IP was set for the fractional $\frac{1}{4}$ cor of 21, on the Bo Ro Line, and a $1\frac{1}{4}$ " IP at the intersection of the S $1/16$ Sec line with the Bo Ro Line.

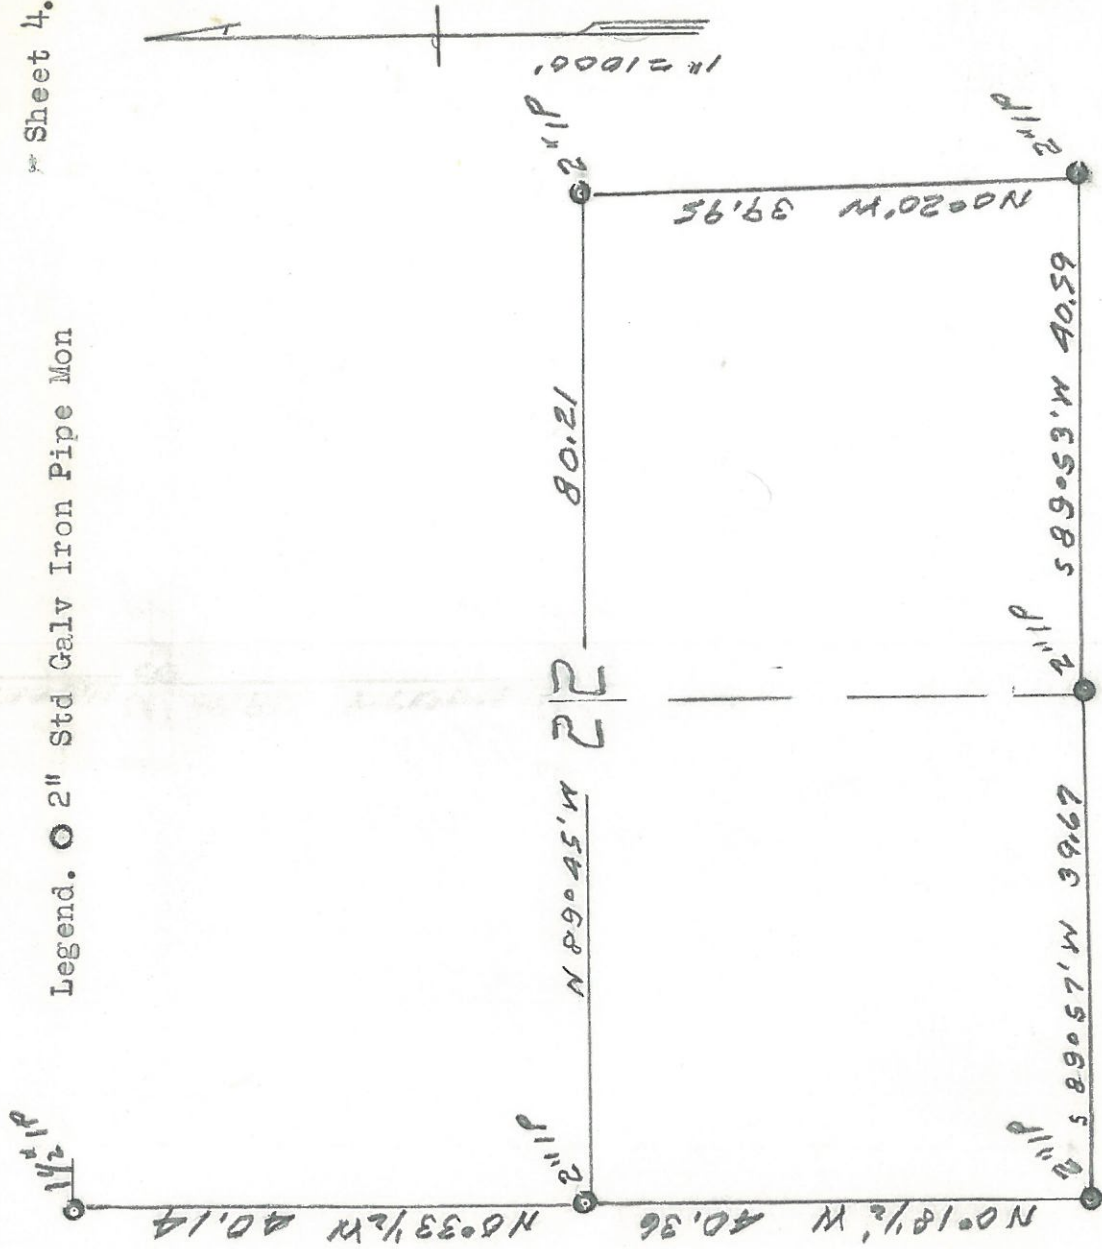
Section 22, T 7 N, R 10 W, M D B & M.

¼ Cor Sec 22-27. Triangulated from near the S E Cor Sec 22 to vicinity of probable location of the ¼ Cor, and found a well established fence corner, fences running south, east and west, which answers calls for topog immediate vicinity, but unable locate either of BT's called for. Accepted as correct location of ¼ corner.

Cor Sec 22-23 26-27. To find this corner, triangulated across from near the W 1/16 Cor of Secs 27-34, to near the tentative location. Checked for location of BT's, with no success; all over 2 chains from corner, and in cultivated fields. Interview with elderly residents developed that the public road, now known as Morelli Lane was established as 50 links wide, with the center at this point 25 links north of a well established R/W and property corner. Using the mean of said property fences, set 2" LP as Sec Cor, which all con- sulted decided was as near the original corner as it was now possible to re- locate same. Later calculations of position developed that this point was only 1.1 feet east of a point 81.04 chains due north of the SE corner of Sec 27.

¼ Cor Sec 22-23. In summer 1958 went to this corner, which was found by Dennis Morelli, in a resurvey of family lands, Found a redwood stake, marked "11.5 M", (2.5 Miles north of South line of Twp.) on the control line which was the basis of control in the subdivision of the TWP. from this point, using Magnetic variation of 19¼°, E, found depressions left by decaying trees in the exact location called for as the two BT's. This point in an east and west fence line only a few feet east of another fence running south. Set 2" LP replacing stake found, There also was a stake marked ¼ a short distance to the South, set by unknown persons.

The NE Cor of this section lies in an open field, and to date have made no attempt to locate it. nor the ¼ Corner of 15-22.

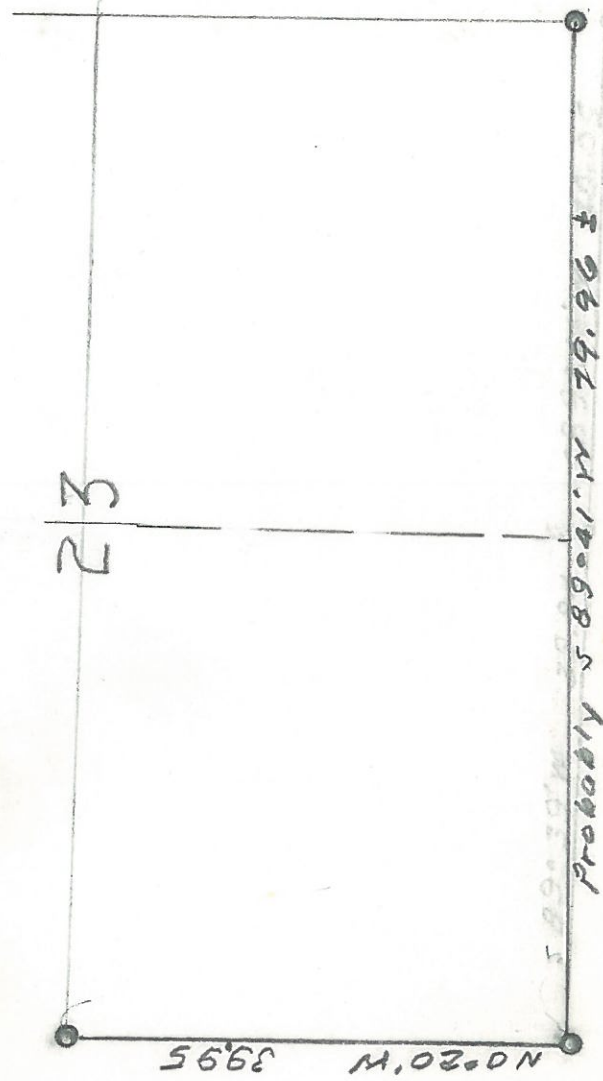
Sec 23, T 7 N, R 10 W, M D B & M.

¼ Cor 23-26. This ¼ corner is in the traveled way, Morelli Lane, and is defined as to easting by the existing fence and property line, with deed to the Pique Tract calling for its being 12 chains north of the S W corner of that tract, which would place it 25 feet north of the Nly R/W fence corner. Set 1" IP at that location, in road ditch, about 1943, but has now been destroyed by County road forces, who installed a road drainage culvert on ¼ section line. True location is probably some 23 feet north of the R/W fence corner.

Cor Secs 23-24-25-26. When the four 40's around the section corner were divided, the corner itself had not been found, and an arbitrary monument was set as a property corner, and deed descriptions were not tied to the Section Corner. The actual corner was found at a later date, consisting of a stake in the remains of a mound of stones, and from this stake two of the BT's listed were found, which checked for bearing and distance. Set standard 2" IP, and restored the mound of stones to Bureau of Lands Specifications.

Note. Before the ¼ and 1/16 corners on this line between Secs 23 and 26 can be located on the ground, it will be necessary to rerun the line between the section corners, came to this corner (23-24-25-26) on four loops, over a long period of time, and the closure at the corner leave its true position doubtful, as to bearing and distance from the SW Cor of 23. The deeds to properties in the S ½ of Sec 23 are based on monuments set in Morelli Lane, so that their relation to the True Section Line is of no real importance.

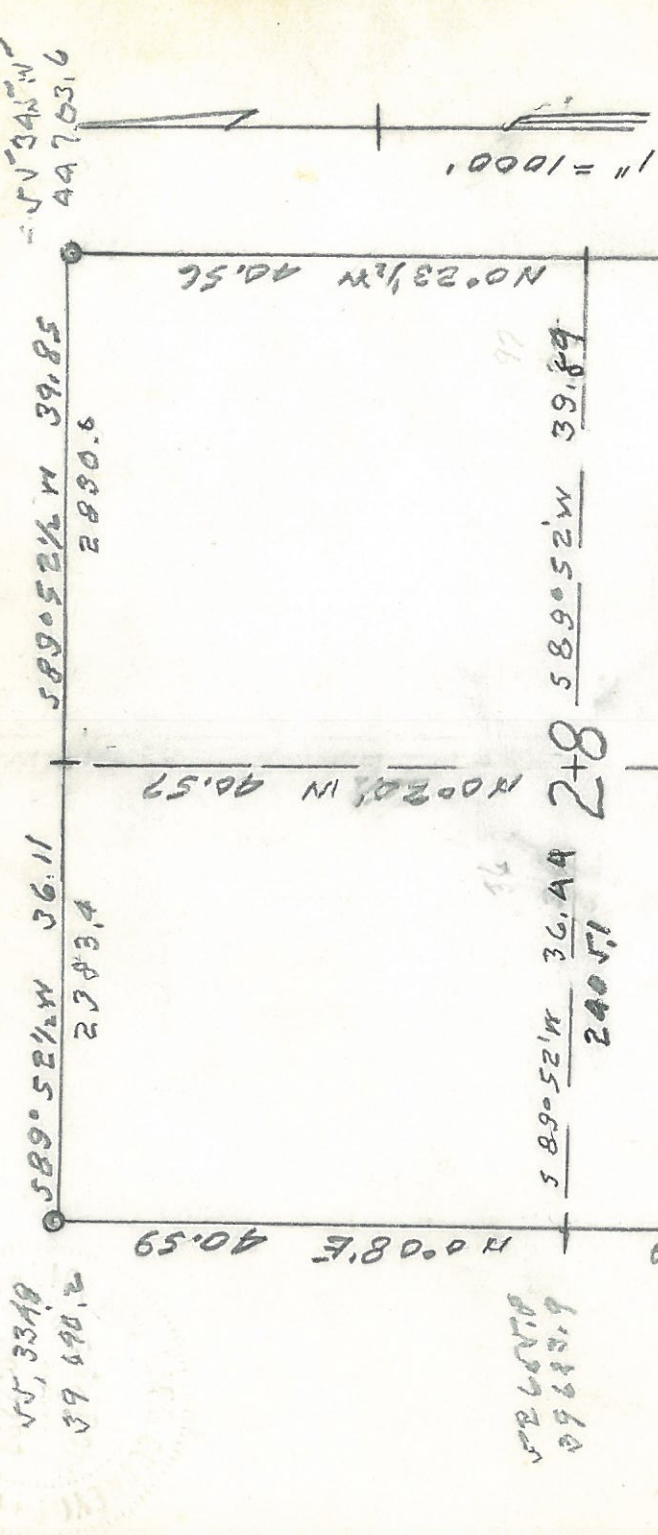
Section 28, T 7 N, R 10 W, M D B & M.

Frac Cor 28-33 on Bo Ro Line. This corner found, running south from M-12 on Willow Creek Road (Ridge Road) on calls in deeds. Found BT's and set 2" IP on Calls for bearing and distance, Topog checks immediate vicinity.

1/4 Cor 28-33. Located this corner, tentatively, from fence lines in vicinity; Used property fence line running east, and by using point on fence line produced 25 links from east line of road, located the remains of the redwood BT, No trace of apple tree marked as second BT. Set 2" IP on call bearing and distance from Redwood BT. Top IP 1/2 foot below road surface, Due to raising grade roadbed, now probably 1 1/2 to 2 feet below surface, Azimuth point; IP on south line Coleman Valley Road bears S 0° 14' 10" E, 478.6 feet.

Cor Secs 27-28-33-34. Came in from W 1/16 27-33. found only one of four BT's still standing, and reset corner on called bearing and distance from that live oak.

1/4 cor 28-27. Diligent search over the years has failed to find any trace of this corner, or the BT's. Lies in Subdivision of Second Addition to Camp Meeker, and probably destroyed during road building operations. Setting on ground would answer no useful purpose at this time.

Note. It seems improbable that the east line of this section was ever measured, or the error of one chain in north would have been picked up. If it was run at all, the probability is that was run north from the SE Cor, setting the 1/4 corner, then ranging through roughly for topog only.

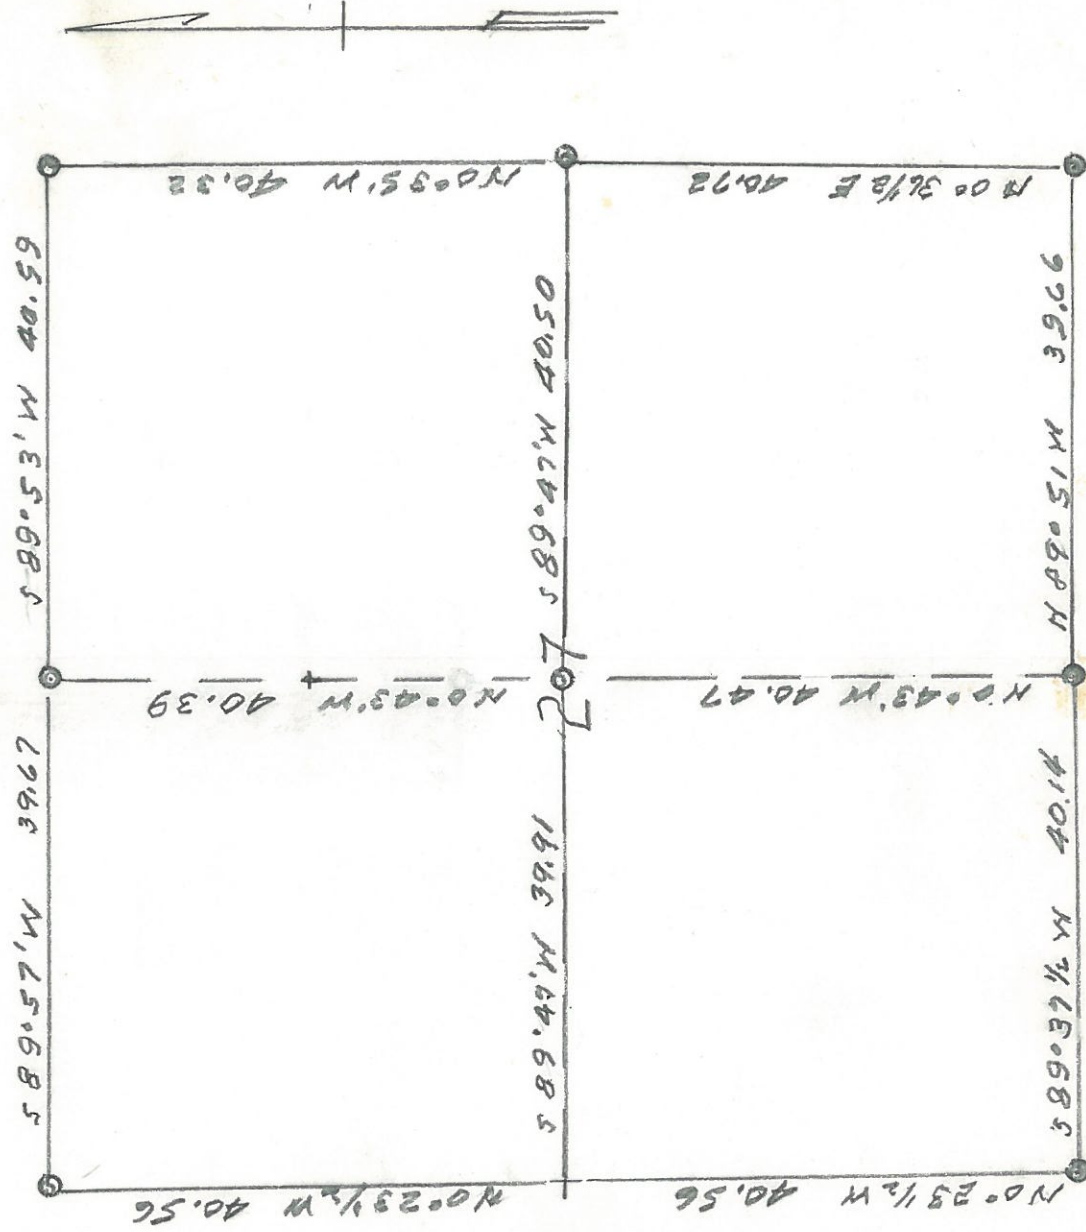
Section 27, T 7 N, R 10 W, M D B & M.

1/4 Cor Secs 27-34. Located this corner, running east from W 1/16 Sec 27-34, found stump of redwood tree described as $\frac{1}{4}$ corner, and set 2" IP in center of stump as corner.

Cor Secs 27-26-34-35. Found iron bar described in deeds as marking corner. Probably set by Simonds, in place original stake, while BT's were in existence. Position agrees with deed calls for adjacent property.

1/4 Cor Sec 27-26. This corner was identified by triangulation before its relative position in relation to other corners was determined. A 2" IP was set at a fence corner, a recognized property corner, where it would best answer calls to surrounding properties. Unable to locate either of BT's, as in immediate vicinity of Lapham buildings, and presumably long since destroyed. At a later date, after tabulating data from surveys, found that the distance between the SE and the NE corners of this section 27 was 81.04 ch. instead of the 80. chs. The $\frac{1}{4}$ corner as set, is N 40.72 chs from the SE Cor while Wohl described a fence line as north 40.71. the $\frac{1}{4}$ cor as set is also some 28 feet east of a straight line connecting the SE and the NE corners.

Center 1/4 Sec 27 This corner marked by 2" IP, set according to instructions Bureau Lands, Falls on projection of property line fence running west from $\frac{1}{4}$ cor 27-26.

N 1/16 Sec 27. Set 1" LP according to instructions. Fell in north and south fence line, but fell some 12.6 feet north of an IP supposed to mark the NE corner of Sylvania Heights.

NOTE. Any change in location of the $\frac{1}{4}$ Cor S 27-26 would only lead to trouble and would answer no useful purpose. The theoretical position would be 20 links south, and 42 links west of the $\frac{1}{4}$ corner as set; The Cen $\frac{1}{4}$ of S 27 would be 10 links S of the 2" IP marking the cen $\frac{1}{4}$ as set, and the N 1/16 Cor of S 27 would be 5 links south of the 1" IP set for that corner. which points as set all define property corners and lines.

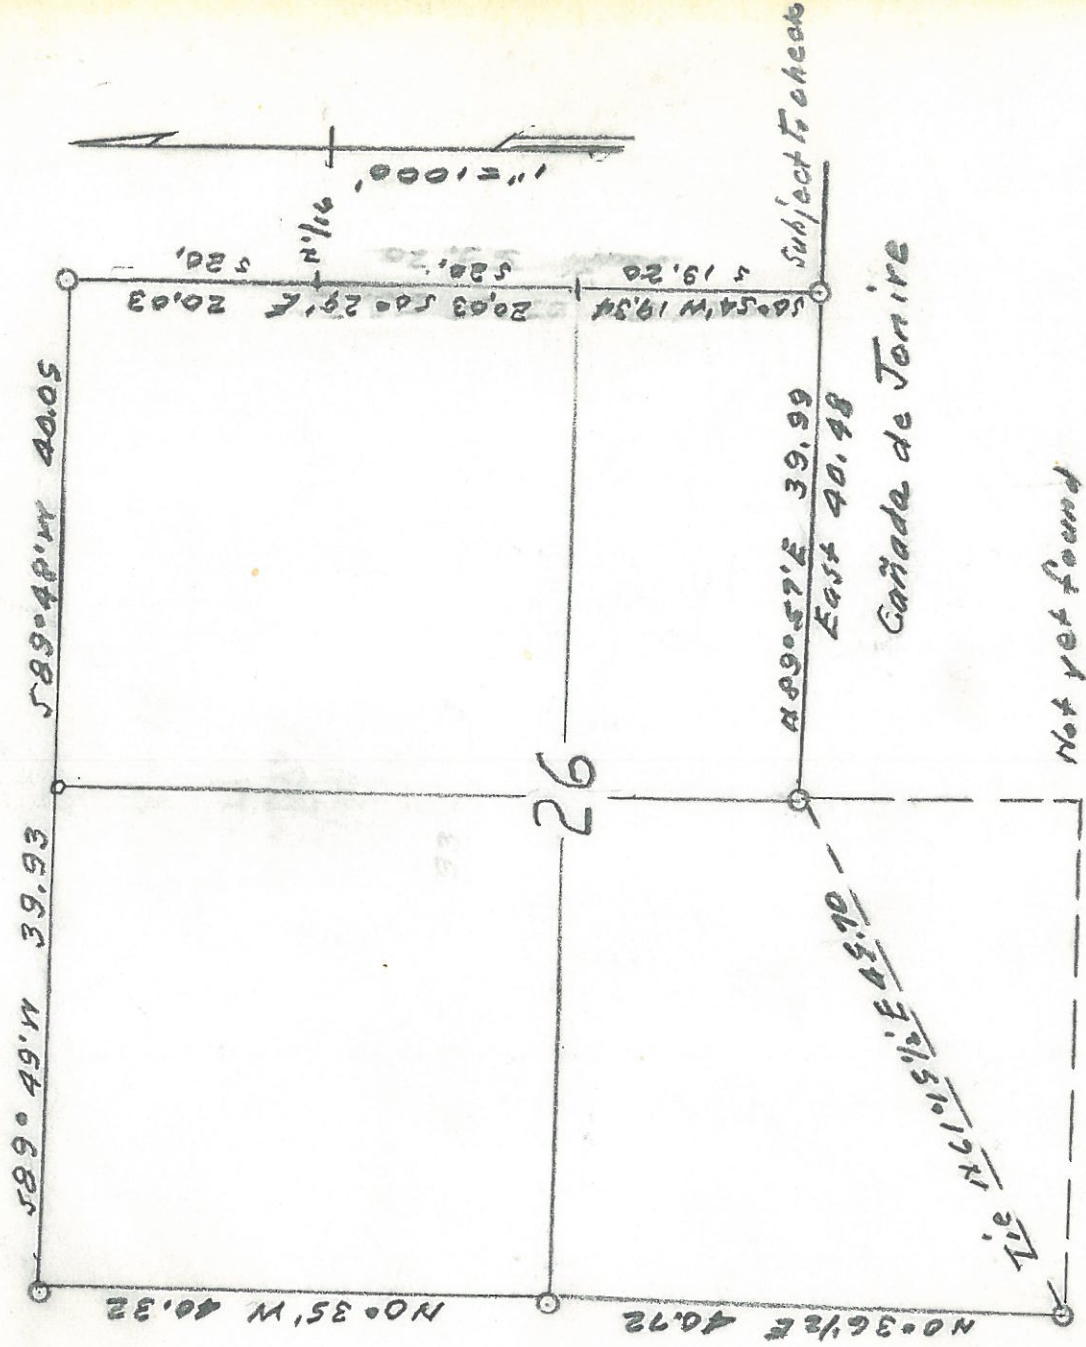
Frac Sec 26, T 7 N, R 10 W, M D BC & M.

NW Corner of Rancho Canada de Jonive; Field Notes; "At 171.90 a post marked C J in field, from which the western edge of a pile of three rocks bears S 2 1/2° E 95 links dist. A rock bears S 72° E, 114 links dist." By using the remains of fences running south and east, set temporary cor. from which was able to identify the rocks called for. and set a 2" LP at a point which would, as near as possible, answer the calls for bearing and distance.

Frac Cor Sec 26-25, on CJ Line. After diligent search, found two trees which answered the calls for the B T s for this corner, by disregarding the calls for bearing except as general, and using only calls for distance, was able to locate this corner very close to its original position. When set the I P Mon at a later date, will make further check for local variation, and other calls. especially as no observable sign that the trees had ever been blazed..

1/4 Corner Secs 26-25 This corner fell in a cultivated field, and all trace of the original corner and B T s have long since disappeared. But the N 1/16 corner between 26 and 25 is firmly established by fences and a fence corner, which we can assume were placed to mark the 1/16 corner while the 1/4 corner was still in existence. We can therefore assume that by producing the line from the corner of 23, 24, 25 and 26, thru the N 1/16 corner of 26 and 25, an equal distance, on that line, we can establish the 1/4 corner in its original location. This also will not disturb any accepted property lines, as have existed for over 40 years without known dispute.

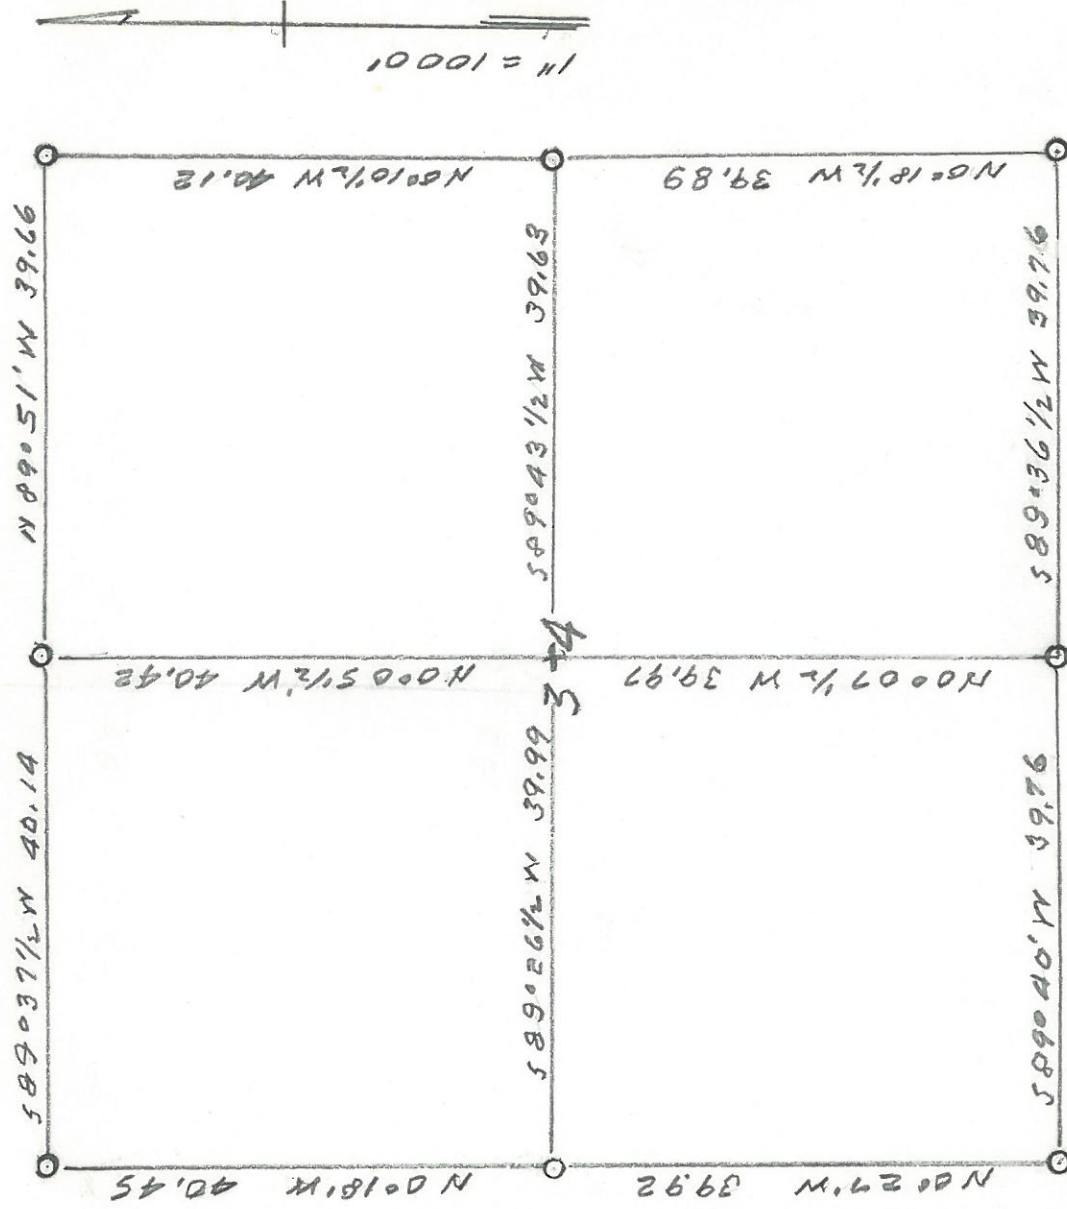
Section 34, T 7 N, R 10 W, M D B & M.

1/4 Cor Secs 34-35. Ran south from NE cor Sec 34; at 40.12 found well established fence and property corner. Unable to identify BT's called for, Later surveys confirmed point monumented with 2" IP, especially monuments found on line between Towns of Occidental and Howards.officially seperated by the 1/4 Section Line.

Cor Secs 34-35, 7-10 & 2-3, 6-10. My remembrance is that W H Williams made tie to the original corner, and his survey showed a tie to point on a redwood stump, which point was found and used in establishing this corner, as well as a tie to a madrona, which checked for distance Later surveys tend to confirm this location as correct. No original BT's were found when corner monumented.

1/4 Cor Sec 34-7-10 & Sec 3-6-10.. This corner fell in the traveled way of the Bittner Road, We identified the remains of a pepperwood BT, but not the redwood. Set 2" IP on call for bearing and distance from remains BT found, and confirmed by checks deed calls in immediate vicinity.

Gen 1/4 Sec 34: Found stake marking this corner, probably set by Cox when line between Towns of Occidental and Howards was established. Later IP was set in concrete by Walter Adams, which now marks corner.

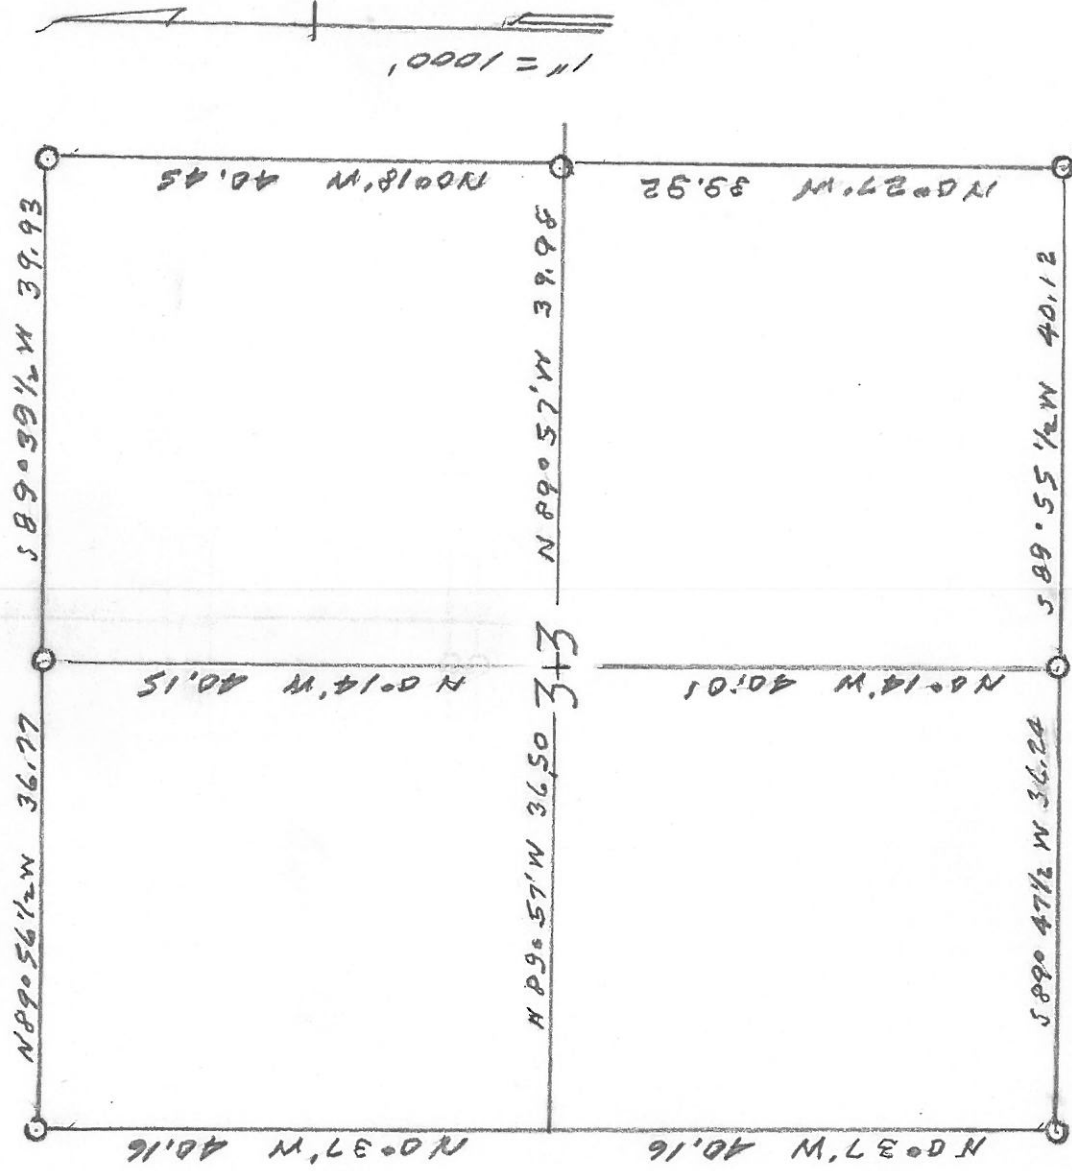
Sec 33, T 7 N, R 10 W, M D B & M.

Frac Cor 33 & 4, on Bo Ro Line, Fay Creek to Opening on lands Rico Calvi; then to vicinity corner, Found well defined fence and property corner. The fences running north, south and west. Set 2" IP at corner. The call for BT is "live oak 10", N 24 E, 80 chs, At 80 links looked for live oak, no sign. probably tan oak marked, and long since gone.

1/4 Cor Sec 33 & 4. Coming from east, was shown original 1/4 stake, in place, and checked for calls. Replaced with 2" IP Mon.

Cor Secs 33-34, 7-10 & Secs 3-4, 6-10. Ran west on random line from 1/4 cor 34-3 to IP property corner, 5 chains west of Sec Cor. From IP ran east 5¹/₂ ch line to 1/4 Cor, for tentative Sec Cor. From this point found one of the 4 BT's called for, and set 2" IP on called bearing and distance. Set 1941. Inspection in 1950 shows disturbed by dozier at 5 chains from prop cor. If to be used for any reason, location should be re-checked.

1/4 Sec Cor 33-34. Ran south from the NE corner of Sec 33, to near fence and property corner. Found both BT's, and set corner from them, at S 0° 15' E, 40.45 chs. Later made check bear & Dist, for location N 1/16 Sec 33-34, which also is Prop Cor.

Gen 1/4 Sec 33. Ran Random line from 1/4 cor 33-28 on Coleman Valley road and Joy Road to 1/4 cor 33-4. and set 1" IP, at the point of calculated straight line connecting the two 1/4 corners mentioned, where intersected by line from 1/4 cor 33-34 to the calculated position of fractional 1/4 cor on Bodega Rancho Line. Checked this location at later date, when ran the N & S cen line to locate property line, as fence dodged back and forth, off line as much as 25 links in places, Only explanation is that line was located, so as to miss one redwood to the right, the next to the left, etc, thus equally dividing timber, and leaving no large trees on line. Have observed other cases where this obviously was done.

Note According to the way the West line of this section, the Bodega Ro line, is fenced, it is impossible to arrive at any definite conclusion as to how, if ever, run by a surveyor. As far as can now determine from notes, Was originally run in summer 1857, var 16° E. Then Retraced in 1867, Var 16° 45'. Undoubtedly the two lines only coincided at original mile points, with probably line trees marked both lines, then when fenced, ran from line tree on one line, to line tree on other line. Seems logical.

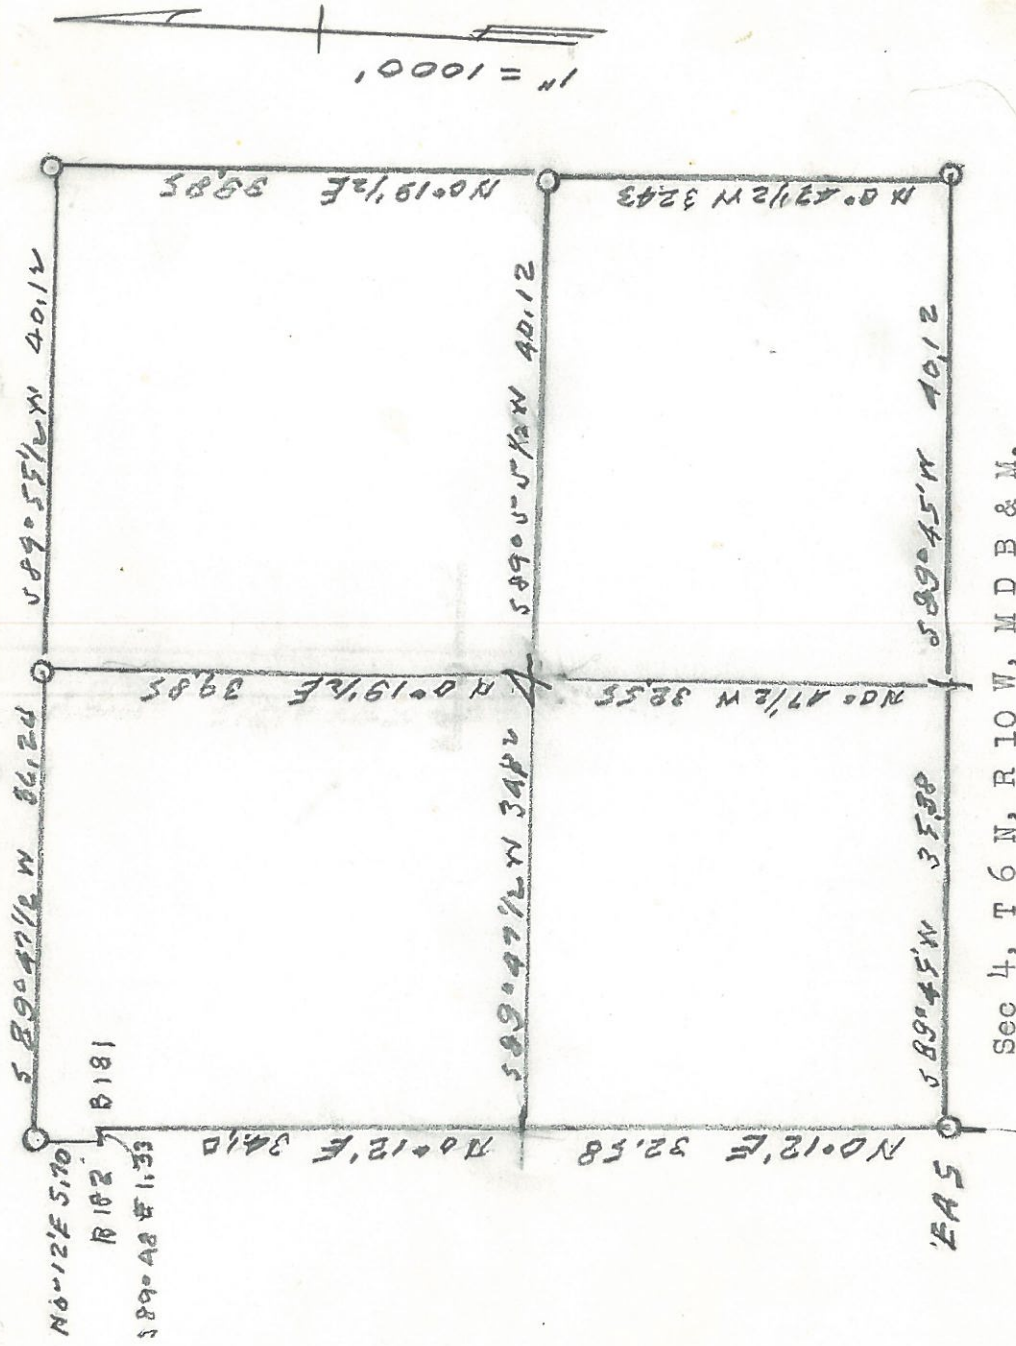
Sec 4, T 6 N, R 10 W, M D B & M.

Frac SW Cor Sec 4, E A 5; The NW Corner of Rancho Estero Americano.

Came west to this corner, along the Taylor Road, checking on lot corners on the north line of The Redwood Tract, to calculated position of corner. Field notes listed two pines and an oak as BT's, The 5' pine had died, and was sawed off, plainly showing scar of blaze; The 3' pine had been felled and the stump rotted away, but leaving the heart of the stump intact. Using the blaze on the 5' stump, and the point where the blaze on the 3' stump should have been, 1.5' from center, set the corner, using angle between calls for bearings and called distances. Distances checked within fraction of link This shows definitely that Bigley did not take distance to center of link crown of roots as presently required, but to the center of Blaze. This is the first time have had confirmation of my belief that this was accepted practice in the 1850's and 1860's.

Frac Sec Cor of S 4, on E A Line. Found a fence corner, being a property cor and from this located the remains of one BT, and set corner according to call calls.

1/4 Cor Secs 3 & 4. Ran south from Bittner road, with property fence as guide, to tentative location, Search revealed remains of one BT, Set 1/4 cor as per calls, Fell close to fence corner.

Note #2 The property line fence running south from the NW Cor, ignores the 1.33 chain offset at B 182, and continues south on a direct line. Search in spring 1958 failed to reveal any trace of BT's, for either B 182 or B 181, using both distance of 5.25 and 5.70 from frac corner.

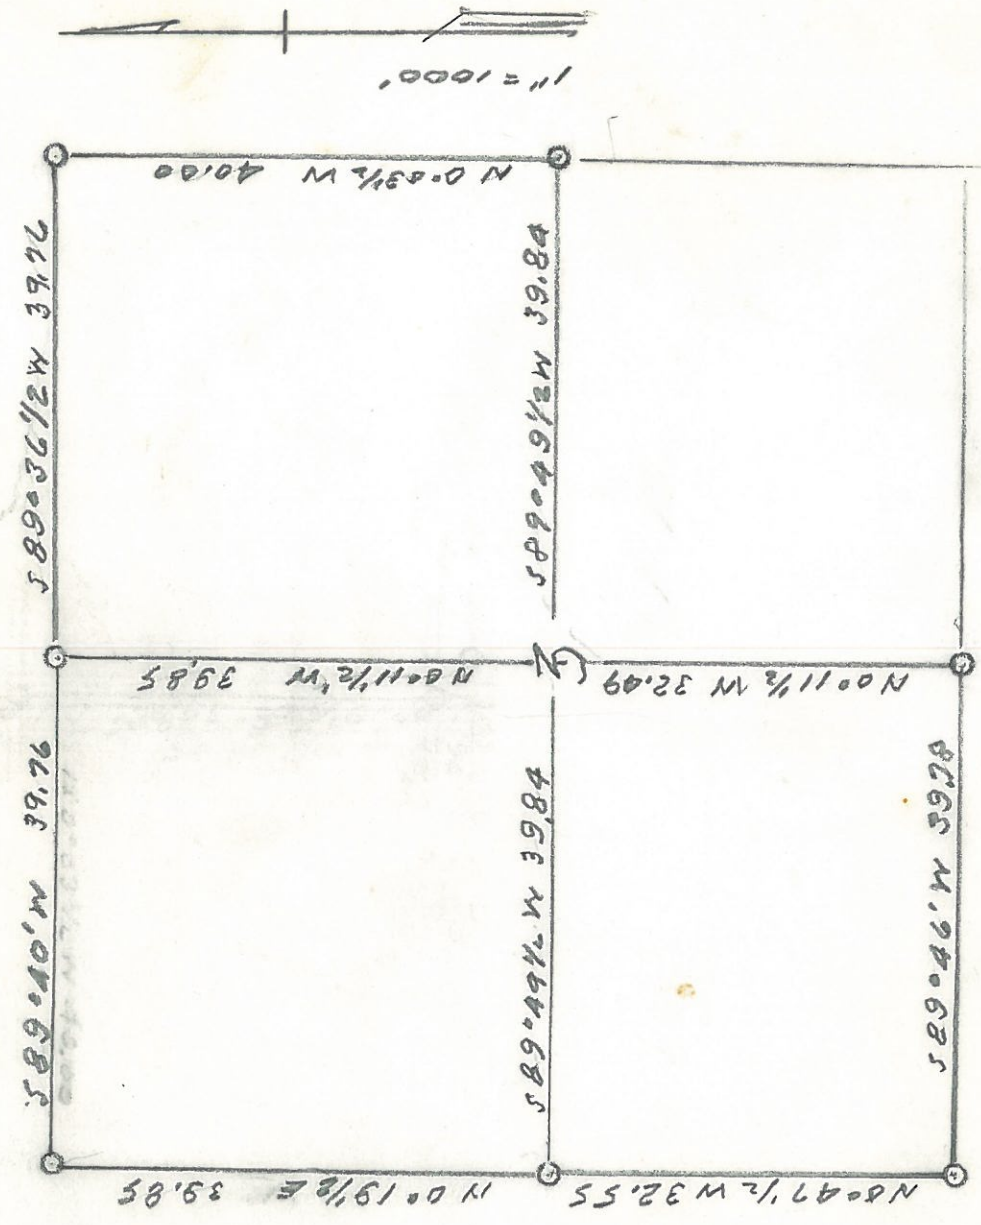
Sec 3, T 6 N, R 10 W, M D B & M.

1/4 Cor on E A Line Ran east on Americano Line, from SW Frac Cor, and found property fence corner, which checked for bearing on Rancho line. After search, casual, did not find corner between 3 & 2 on E A Line, so accepted fence corner as true corner. Further search is indicated.

1/4 Corner Sec 3 & 2. Ran south from NE Cor, and at 40 chains, in fence line, for tentative corner. Identified one B T positively, the other probable, which checked tentative location.

1/4 Sec 3. Calculated this position, according to instructions, and set either 2" or perhaps 1", IP. (Notes do not show which.)
