Report on monumenting of Section Corners of a portion of T6-R10 & T7-R10, M D B & M, bounded on the west by the Bodega Rancho; on the south by the Rancho Estero Americano, and on the east by the Rancho Canada de Jonive and the Rancho El Moline.

Sheet 1.

A portion of T 6 & T 7 N, R 10 W, M D B & M
 Bounded on West by the Bodega Rancho;
 Bounded on South by Rancho Estero Americano;
 Bounded on East by Rancho Cahada de Jonive;

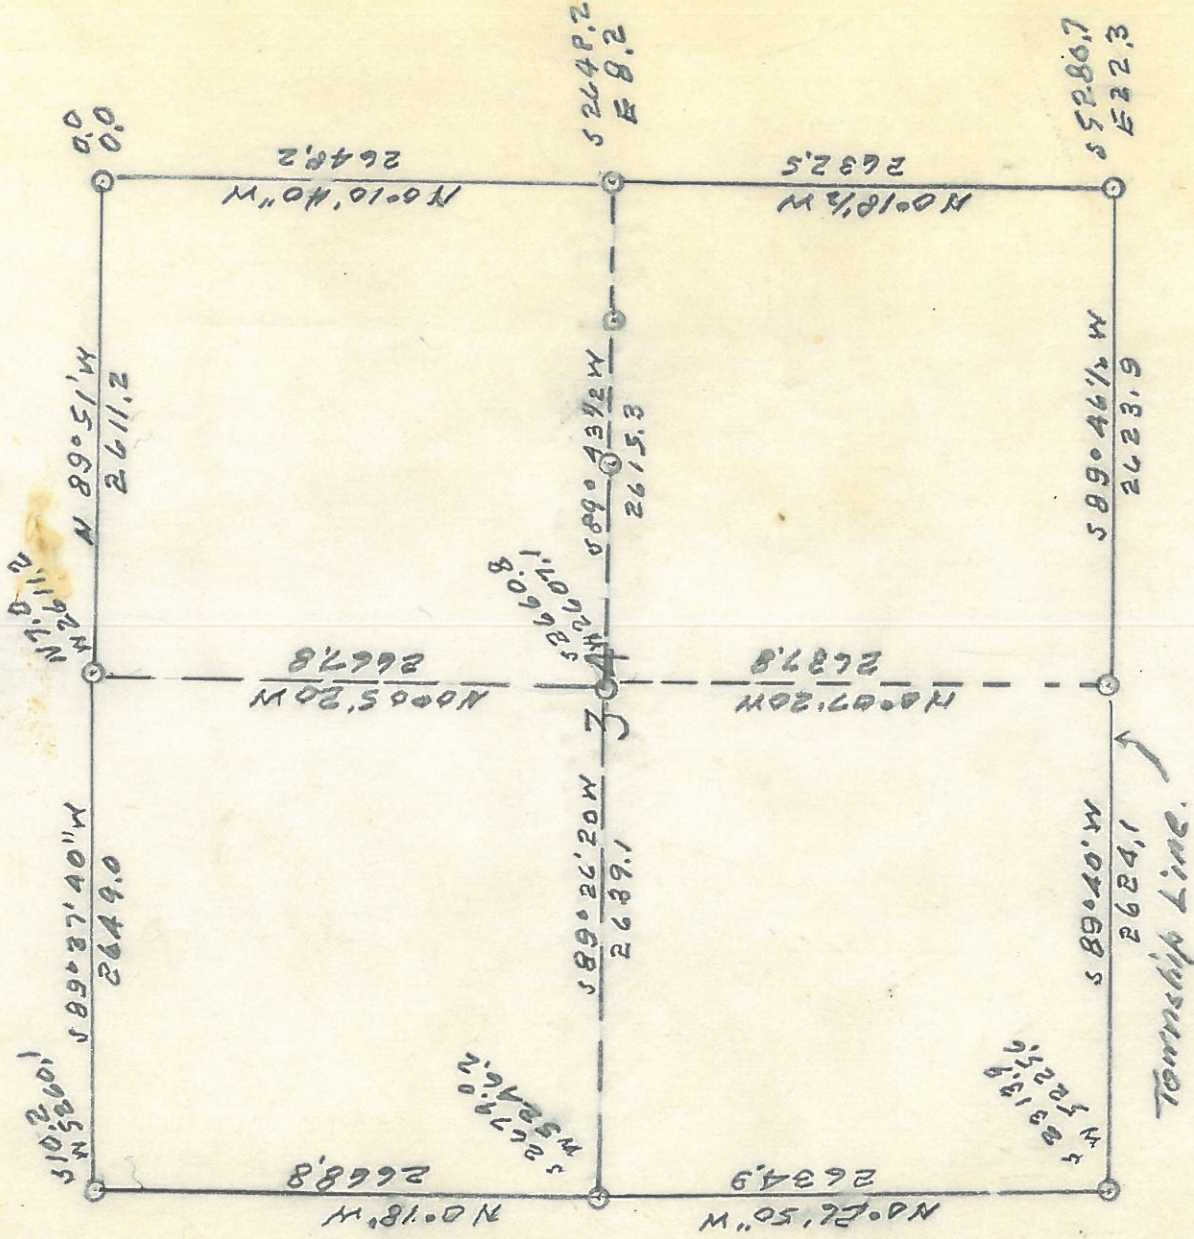
Sec 34 - 7 - 10 M D B & M

Started at NE Cor in 1941 - and over the years since ran south on E Bdry to S E Cor. West on So Bdry to SW Cor; N on West Bdry to NW Cor, and E on Td Line to N 1/4 - Ran West from E 1/4 thru Cen 1/4 to W 1/4 and North from S 1/4 thru Cen 1/4 to N 1/4. Then N to Hampton Rd - to Bohemian Rd sly to N line and East to R.O.B.

From closure on various random lines, estimate that the probable error of position at any corner is probably less than 1 foot.

It should be noted that the bearings are uniformly west of North and south of West. If Mohl had used a variation of 16° 45' E, as he did on the Bodege Rancho East Line, instead of 170° E, he would have had his lines nearer to True.

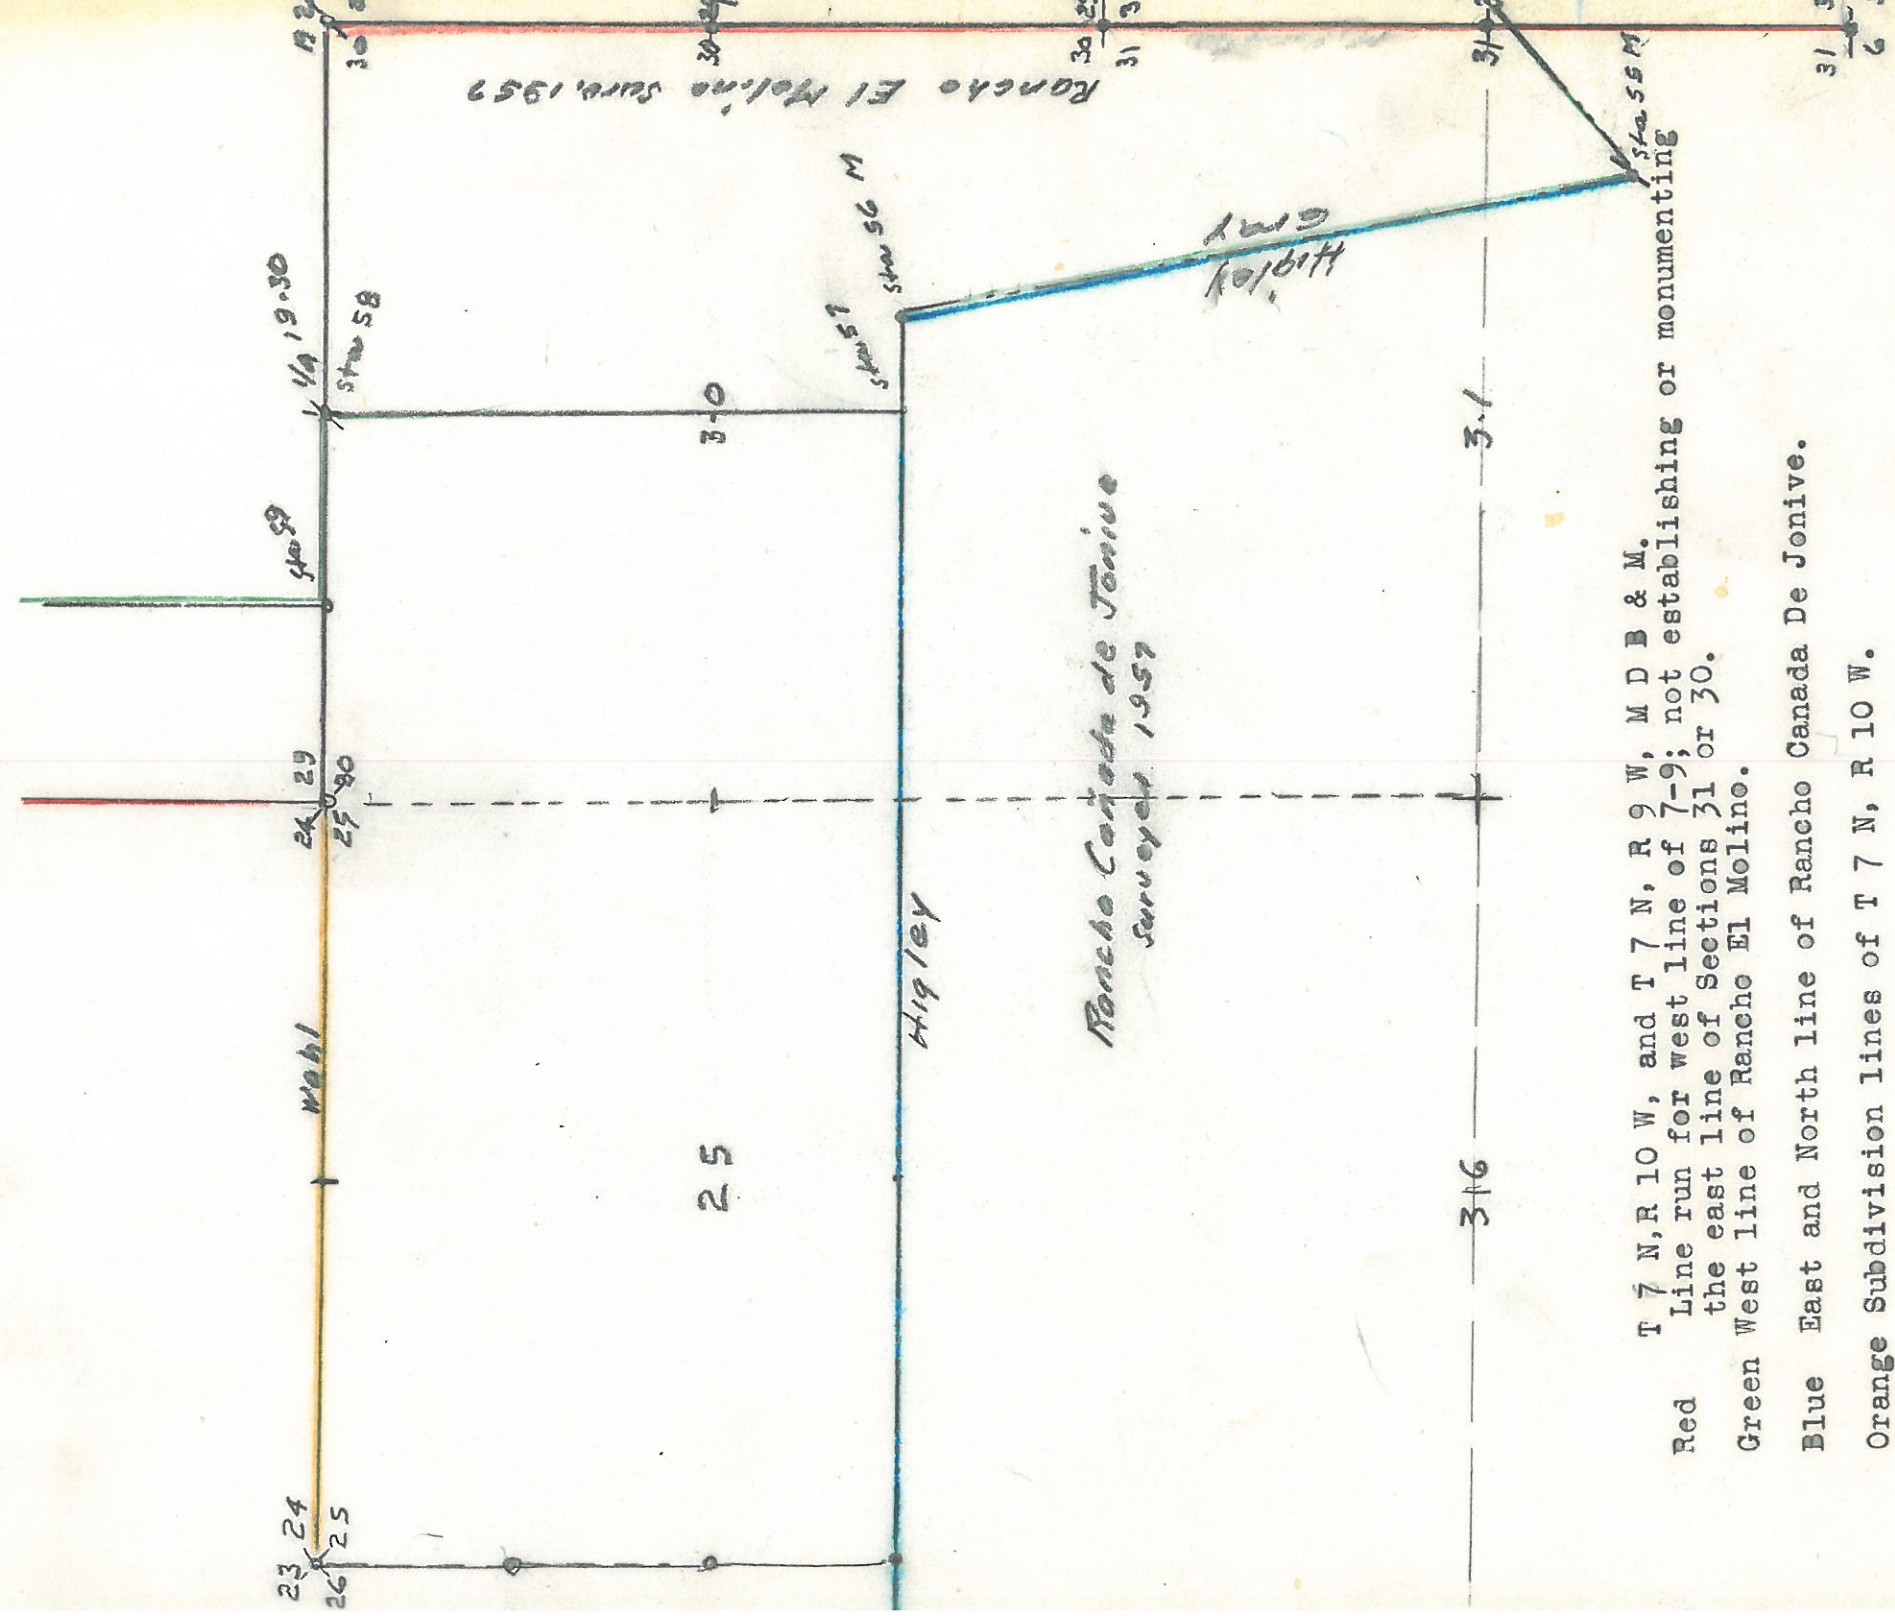
T 7 N, R 10 W, and T 7 N, R 9 W, M D B & M.

There seems to be no indication that the line between 25-7-10, and 30, 7-9 was ever run.

If can reestablish corner of 24-25-30-29, and the south or west line of Sec 29, can run south on a bearing compatible with those bearings, but using old established fence lines as final determinant.
