## Phase I Environmental Site Assessment

Todd Road/ Standish Avenue Signalization Project  
County Project No. C19002  
Santa Rosa, California

*prepared for*  
**Sonoma County Department of Transportation & Public Works**

*prepared by*  
**Rincon Consultants, Inc.**

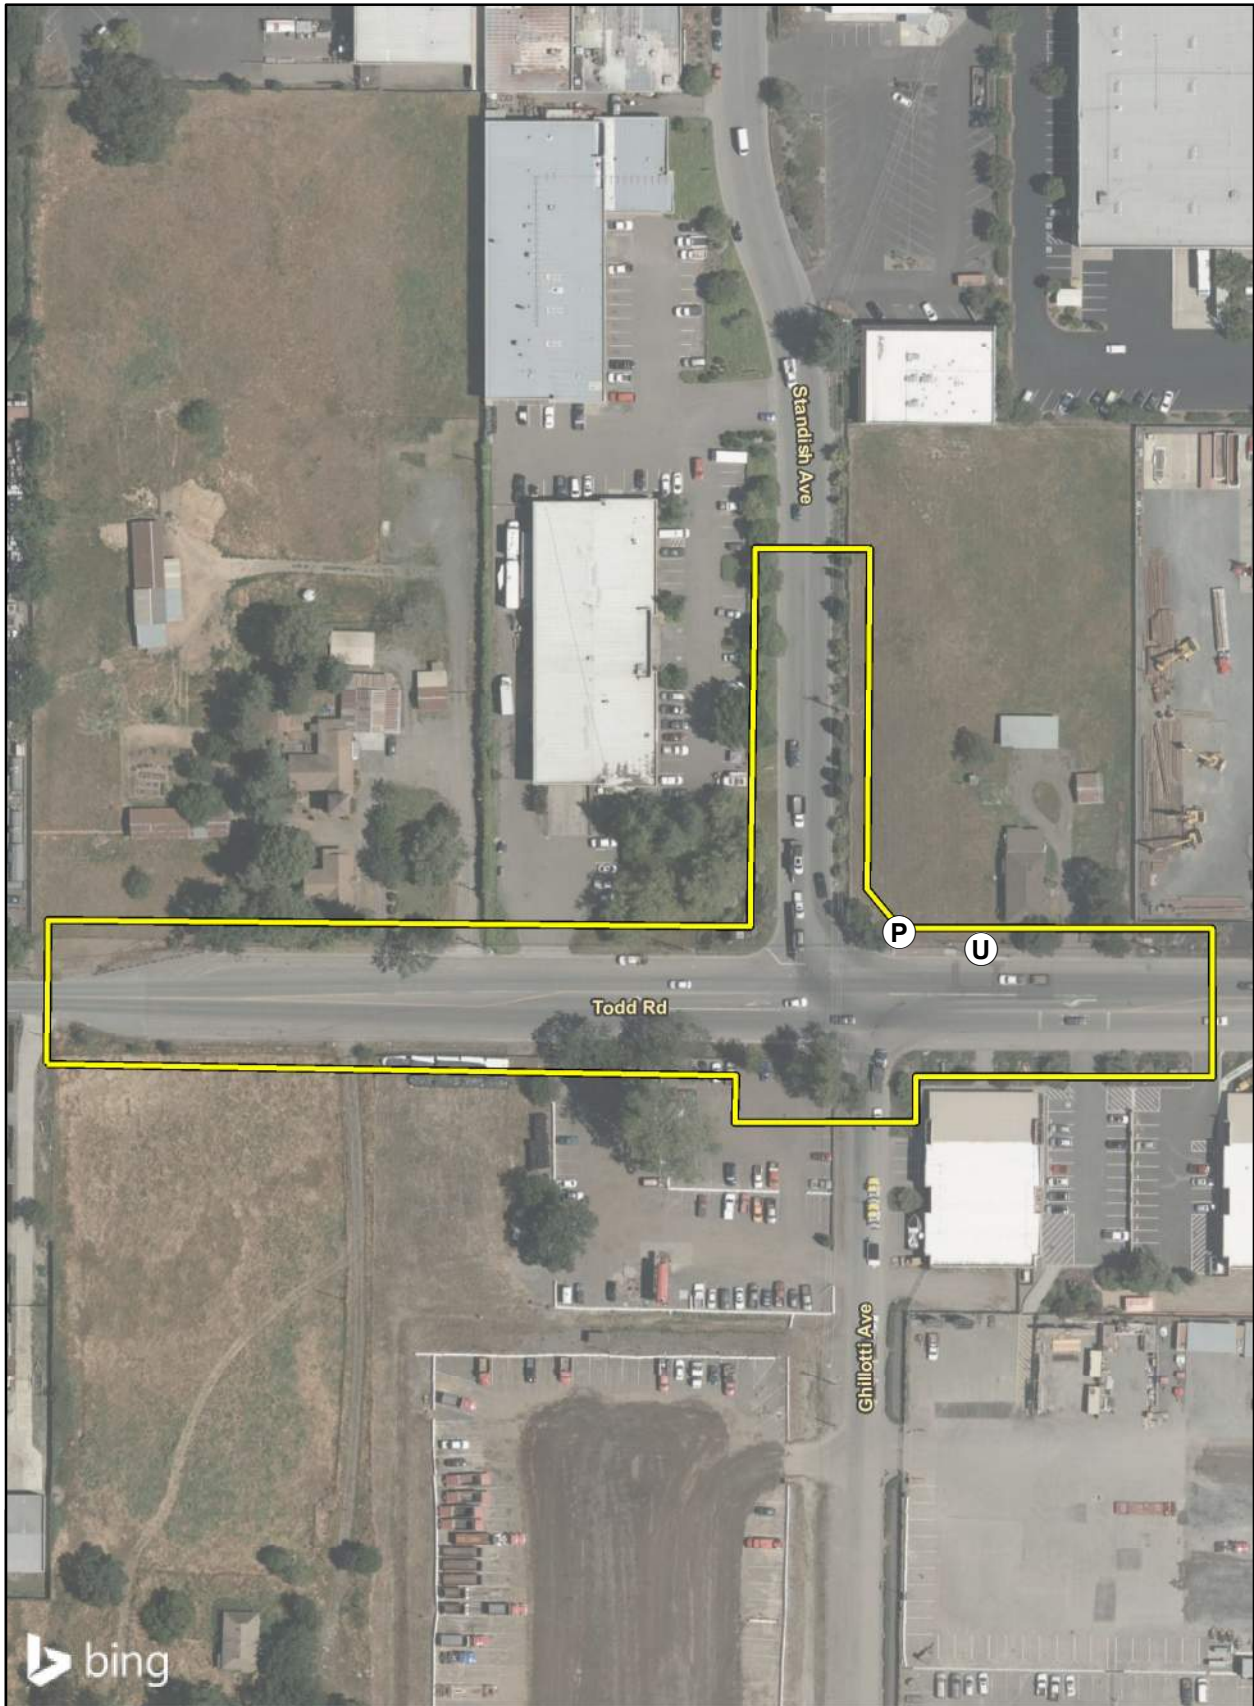
Figure 2

Site Map

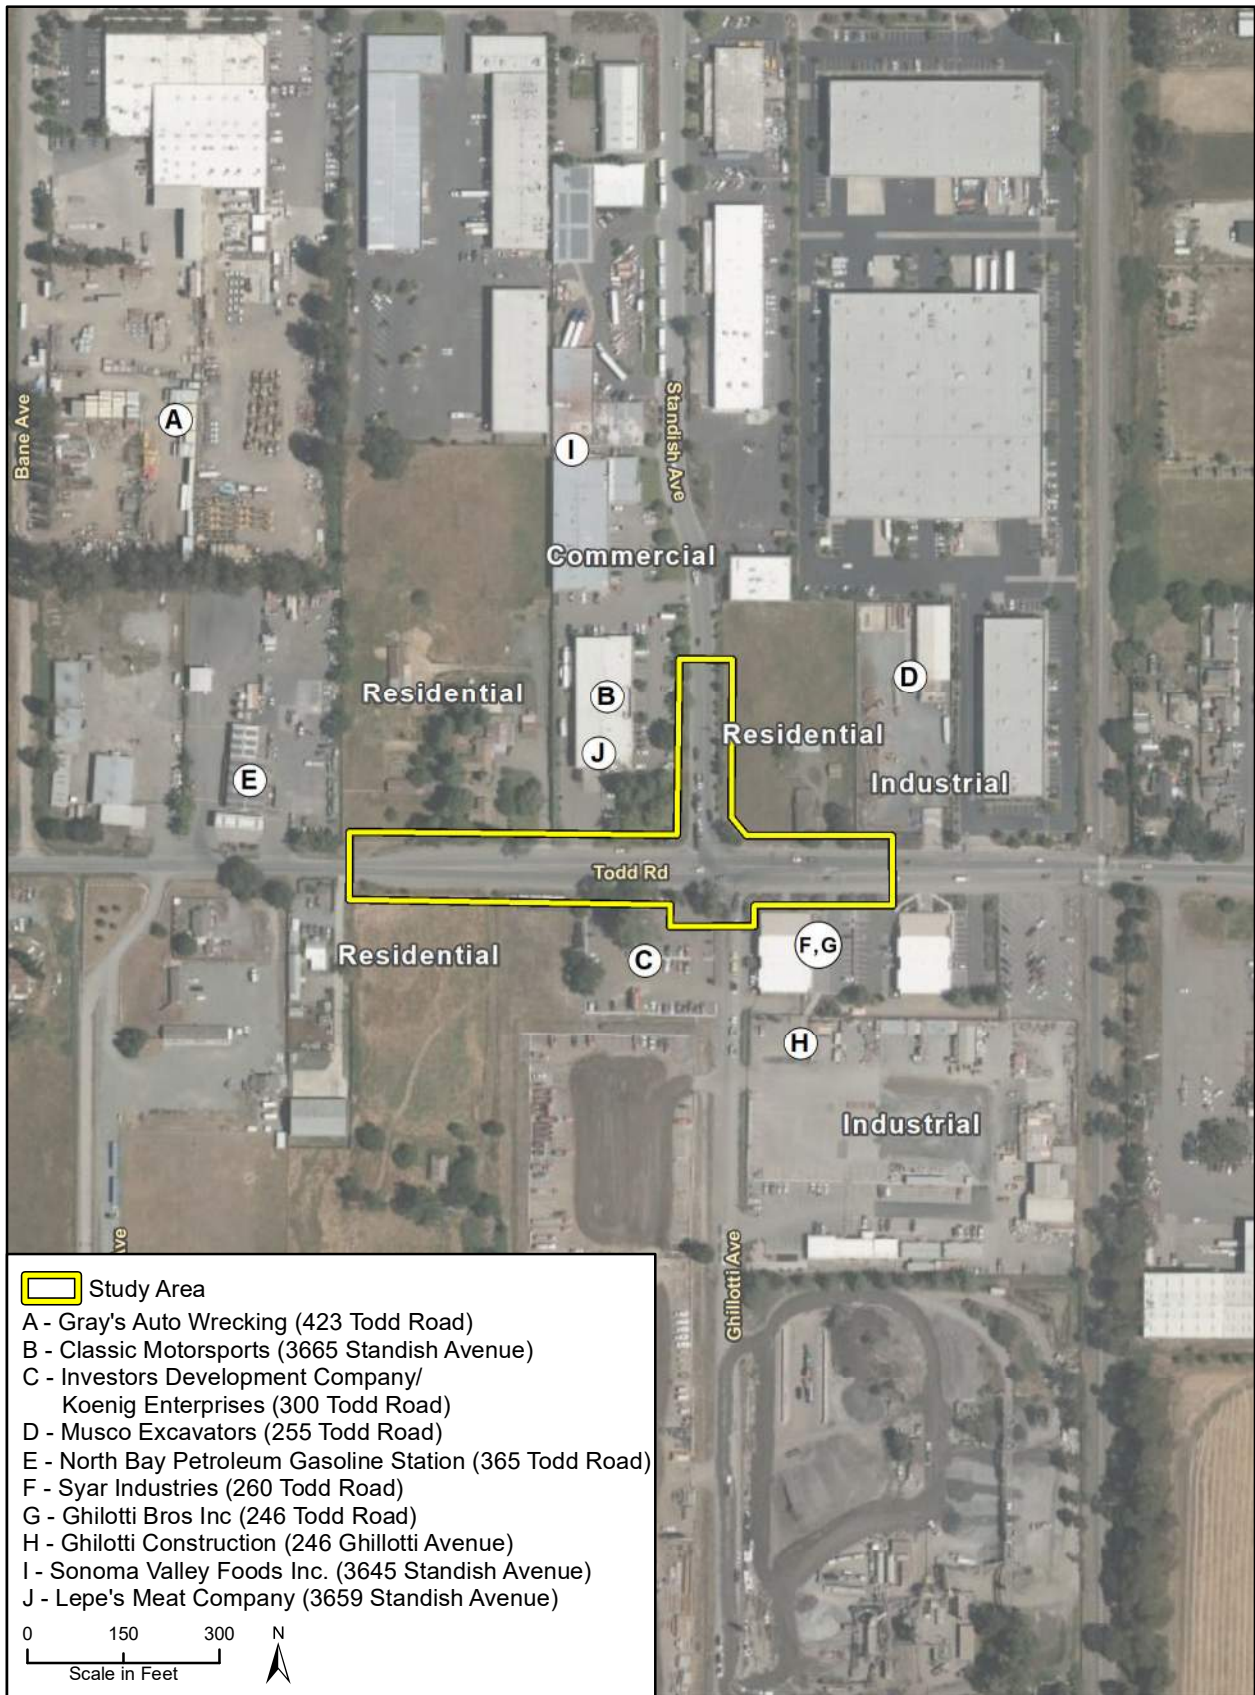
Figure 3

The study area is located in an area that is primarily composed of residential, light industrial, and commercial land uses. Properties in the vicinity of the study area include commercial businesses, a construction equipment storage yard, a gas station and auto repair facility, and single-family residences. The current adjacent land uses are described in Table 1 and depicted on Figure 3, Adjacent Land Use Map.

Adjacent Land Use Map

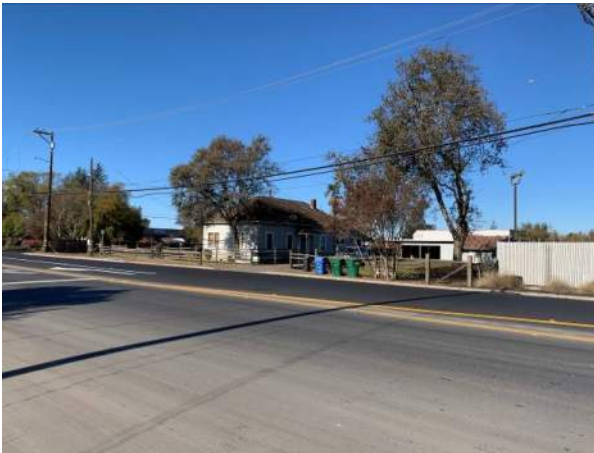
**Photograph 4.** View of abandoned home on the west end of the subject property.

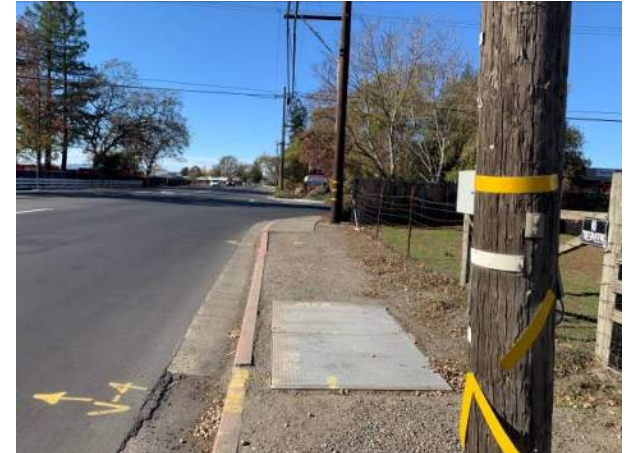
**Possible underground utility.** A possible underground utility was observed on the northern shoulder of Todd Road adjacent to the east of the intersection of Todd Road and Standish Road.

**Photograph 6.** View of the subject property and possible underground utility, facing west
