Biological Assessment Report#

1321 Spring Hill Road, Petaluma, CA 94952
(APN #: 020-050-026)

Updated October 28, 2021

Daniel Edelstein,
Consulting Biologist
&
Certified Wildlife Biologist Asc.

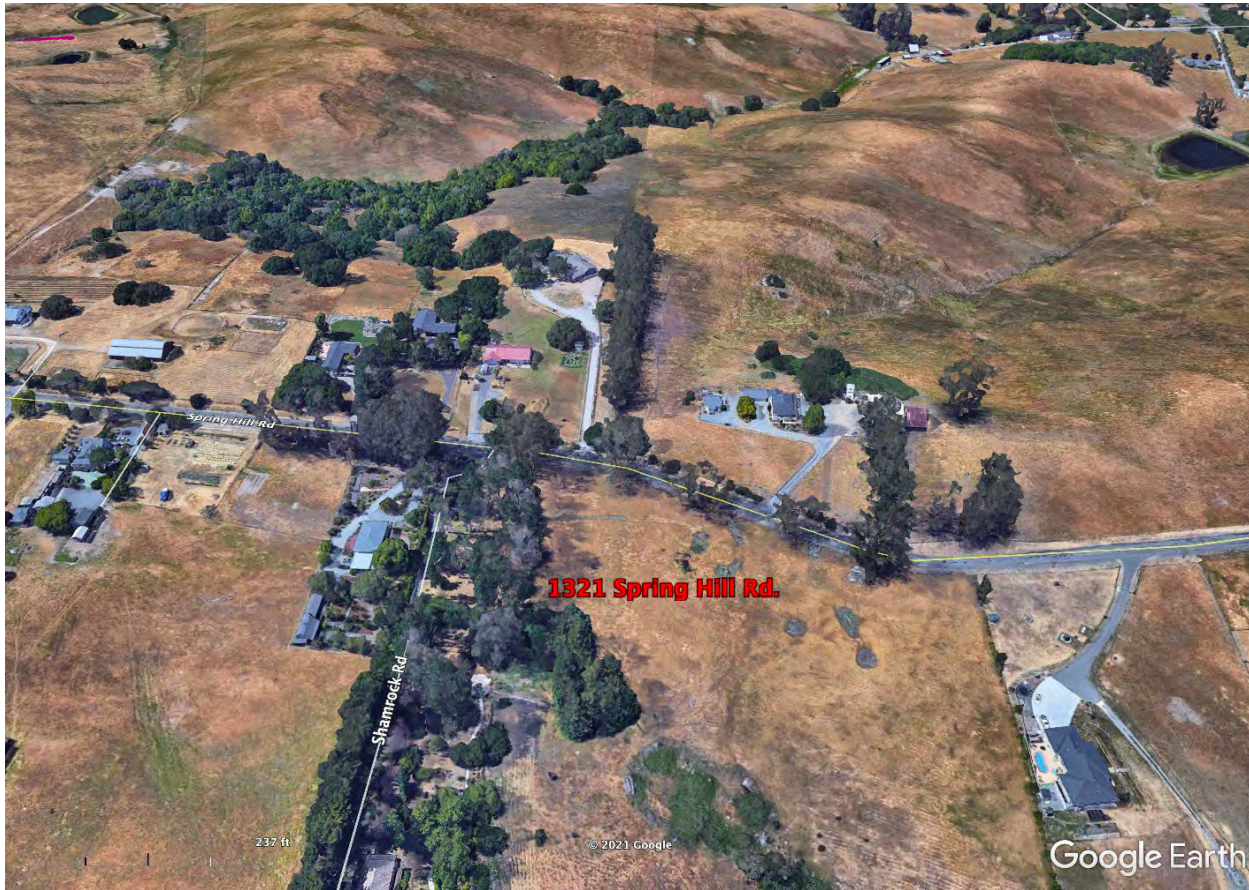
APPENDIX A – Parcel Map – Figure 2

Adjacent parcels along with the center of the site (**red text** address, above) at 1321 Spring Hill Road, Petaluma, CA 94952. The site is approximately 2.75 miles west of Petaluma, CA, Sonoma County. Note the next figure, below: Figure 3 shows the precise boundaries of the site. Figure 4 (also below) shows the professional architectural rendering of the site.

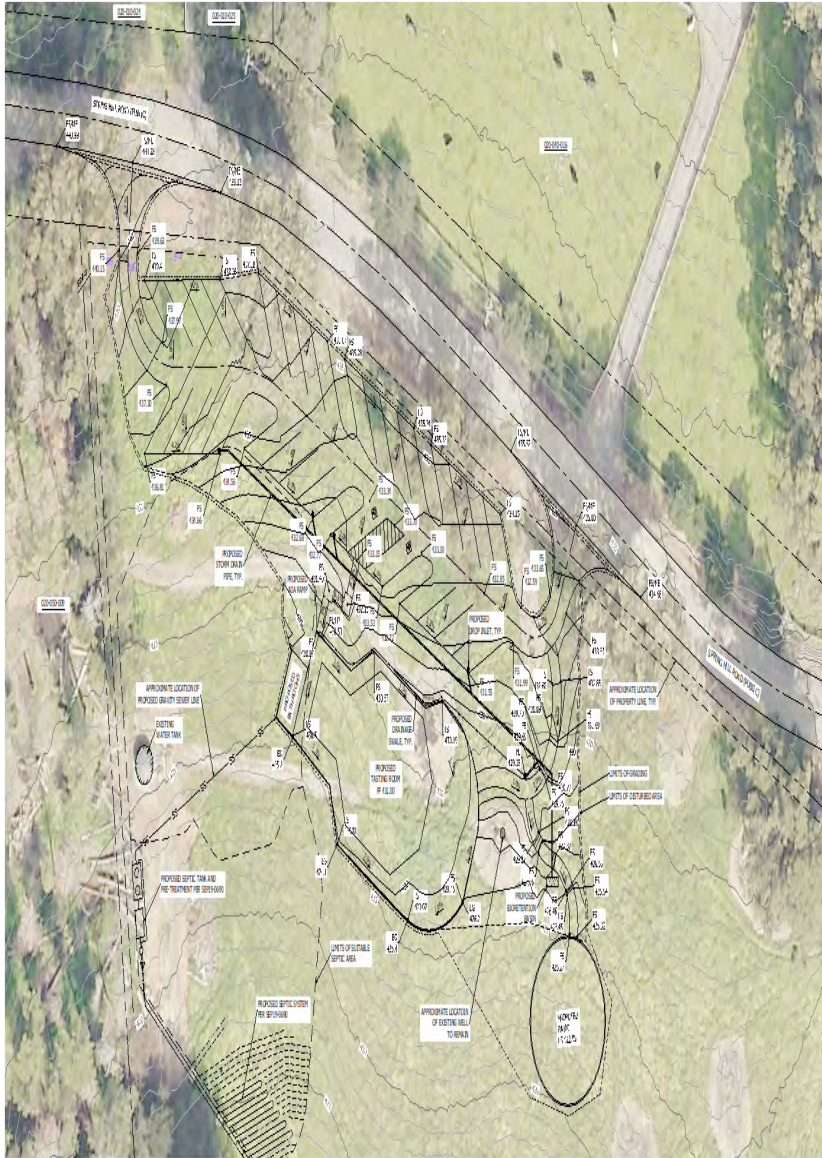
APPENDIX A – Project Construction Area (i.e., construction and staging areas) – Figure 5

- a) the off-site drainage/watercourse (center and top right of the figure, below) that begins at least 190 feet southeast from the proposed construction footprint.
- b) the location of the proposed septic system (southwest portion of the Site; see below figure).

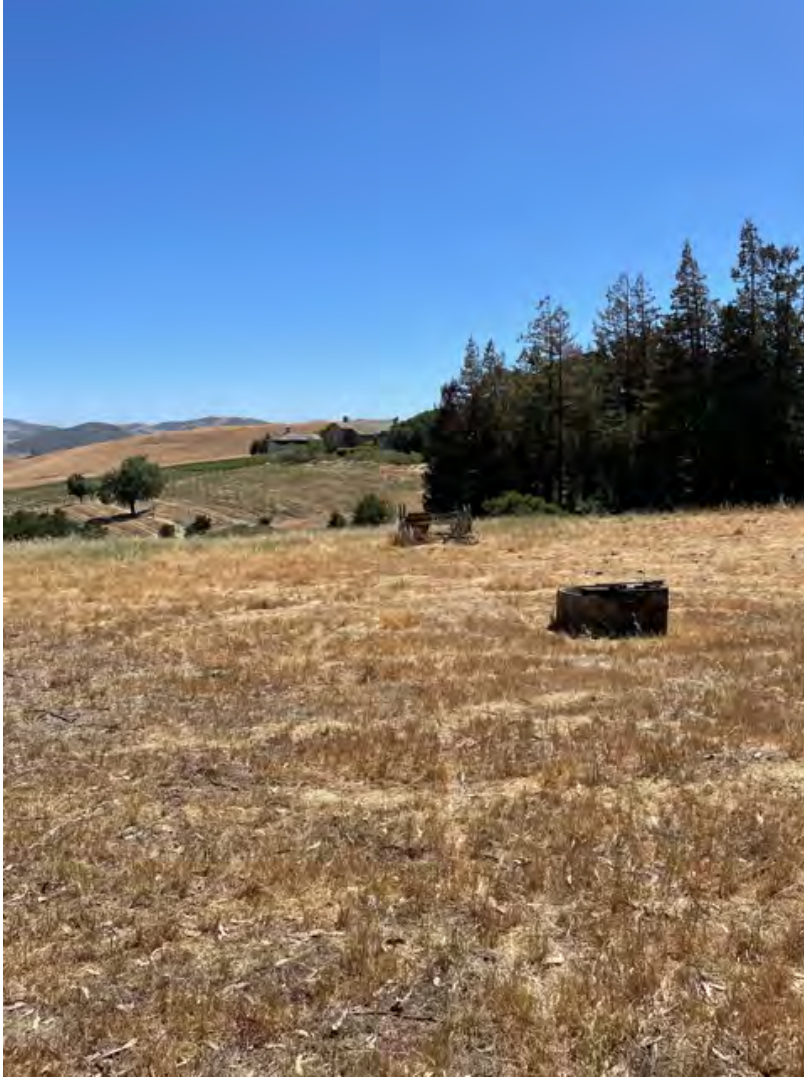
Photo 1 — Looking south, a well (right-center in photo) is shown at the site (1321 Spring Hill Road, Petaluma, CA) along with some of the owner's residential parcel's buildings and vineyards (background of photo) that occur outside the parcel's boundaries.

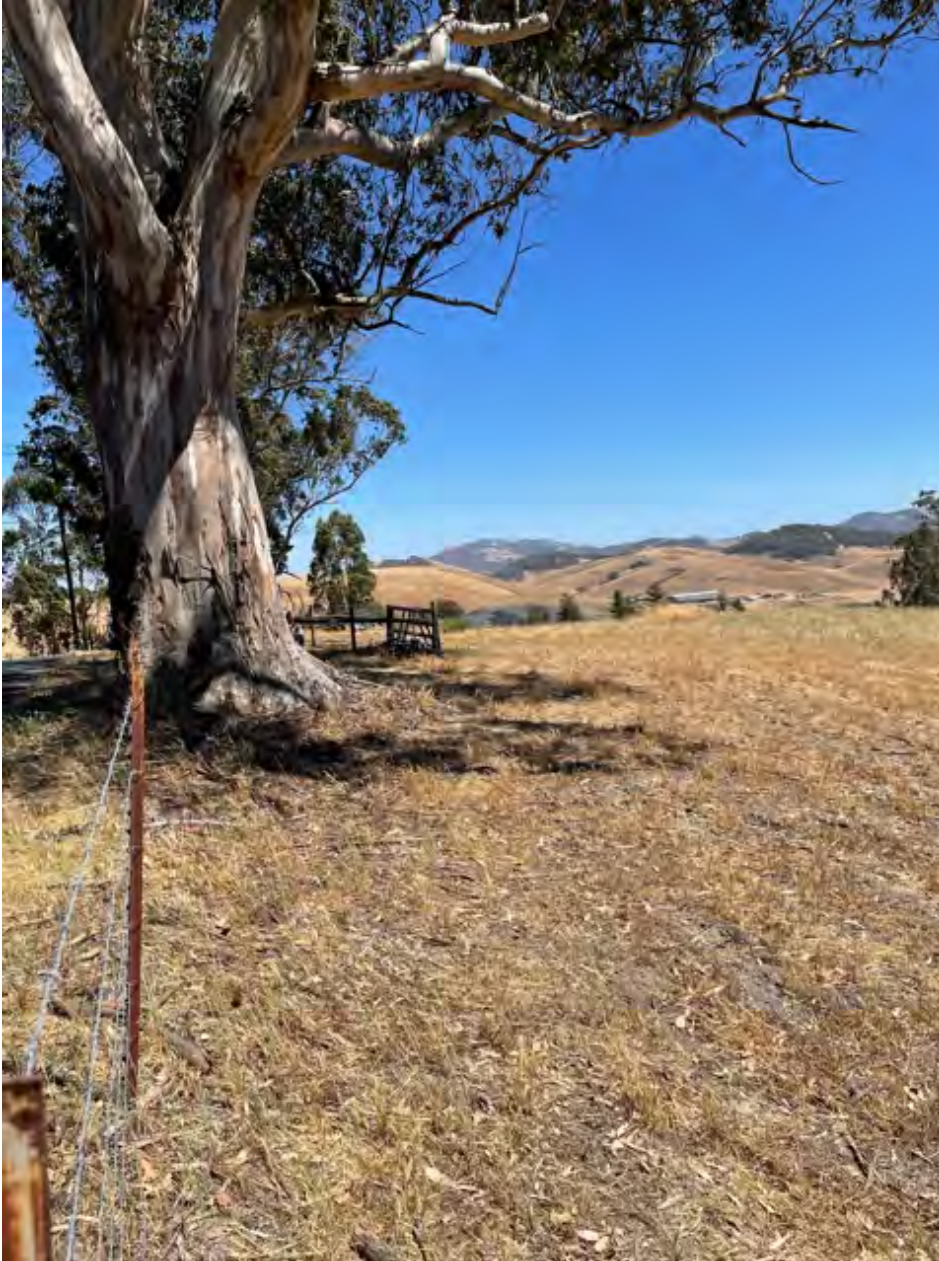
Photo 2 — Looking east, the north border of the site is represented by the barbed wire fence and the Blue Gum Eucalyptus (*Eucalyptus globulus*) tree (left side of photo). The rest of the site exists on the right side of the photo and extends south beyond the scene shown above (See Appendix A, Figure 4.).

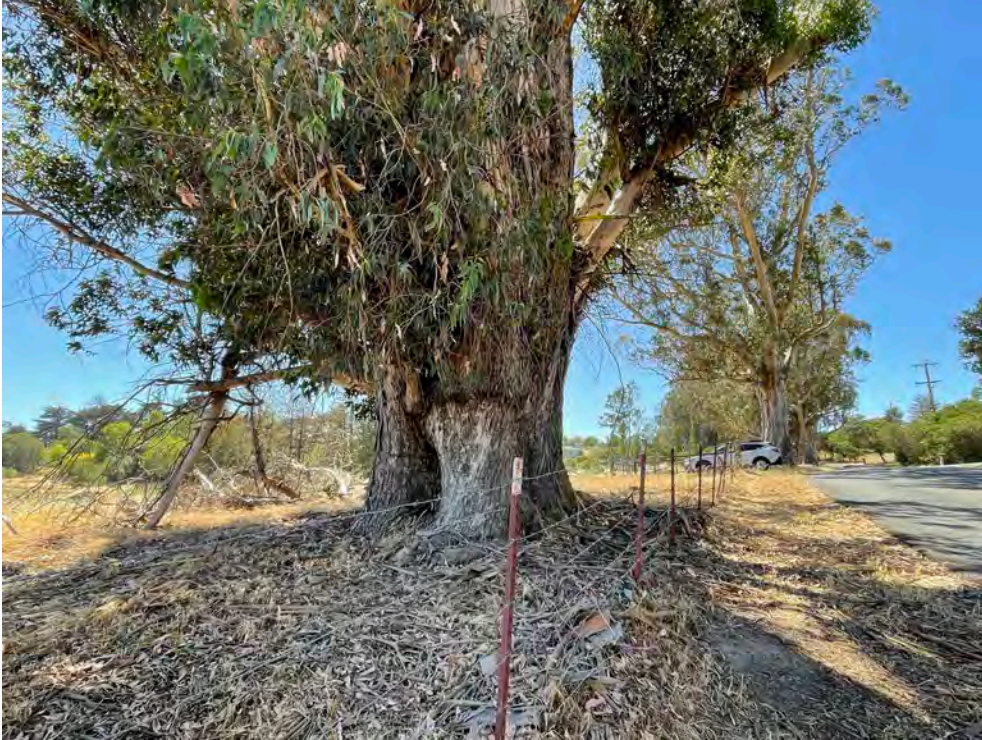
Photo 3 — Looking west, similar to Photo 2, the north border of the site is represented by the barbed wire fence and a different Blue Gum Eucalyptus (*Eucalyptus globulus*) tree (center of photo) that occurs immediately inside the site's north border adjacent to Spring Hill Road. The rest of the site exists on the left side of the photo and beyond toward the south (See Appendix A, Figure 4.).

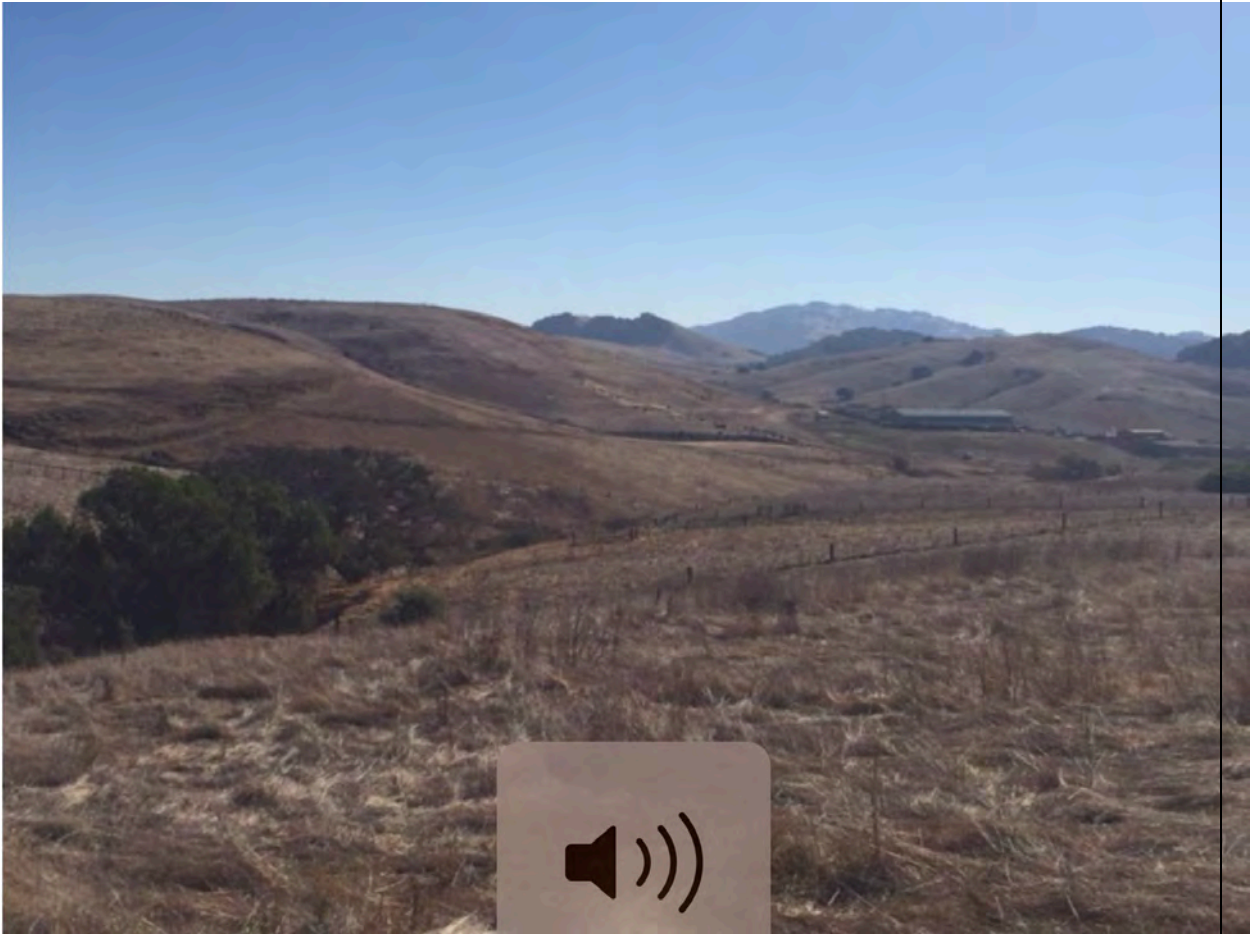
Photo 4 — Looking east from south of the site, a distant view is shown of the trees growing amid the upper banks of the drainage/watercourse mentioned in the above report’s narrative. This drainage/watercourse occurs at least 190 feet or more from the south border of the site at 1321 Spring Hill Road, Petaluma, CA. (See Appendix A, Figure 4.).

b) the presence of water flow or pooled water from winter through late spring/summer usually too shallow or is absent by spring/summer within the drainage/watercourse that begins approximately 190 feet southeast of the Site (See Appendix A, Figure 4 and Appendix B, Photo 4.).

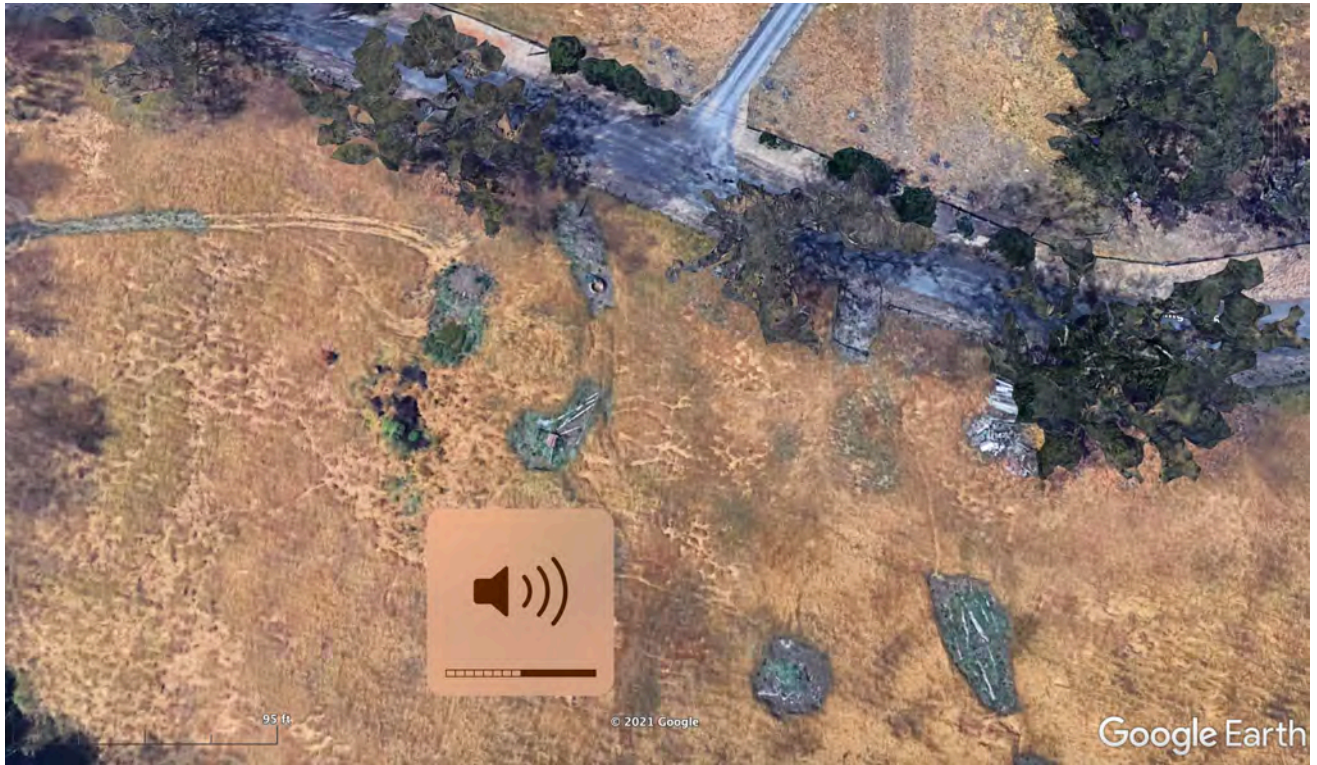
Photo 5 — Looking from overhead, four Blue Gum Eucalyptus trees are adjacent to each other adjacent to the fence line on the northern border of the Site at 1321 Spring Hill Road, Petaluma, CA. See Photo 2 and 3 above.

The even-aged, 110-foot-tall trees are the following diameter at breast heights (DBH) (from left to right in the above photo): 28, 25, 26.5, and 26 inches.

2. See below for more details related to the Site's description and habitat (Section 2, below), including Appendix C, Photo 2, 3, and 5 that show the trees, including an overhead photo of the four Blue Gum Eucalyptus. The diameter at breast height (DBH) of these four trees is also noted in Section 2, below.
