# Aquatic Resources Delineation Report Adobe Road and Main Street Intersection Improvement Project

# Penngrove, Sonoma County, California

August 2023

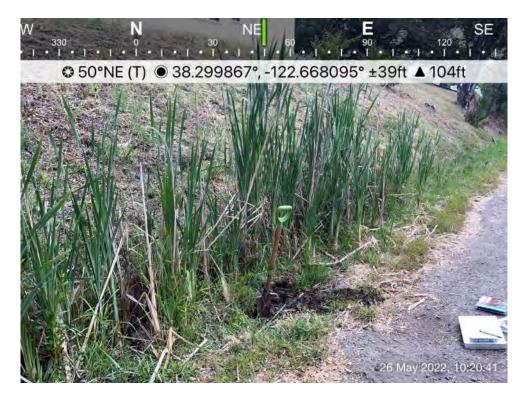
Photograph 1. View of Sample Point 1A in Roadside Ditch (RD-01) on northern shoulder of Adobe Road.

One Roadside Ditch was delineated on the western edge of the project site, running along the north side of Adobe Road near Penngrove Elementary School (Table 2; Appendices A and B). This Roadside Ditch is an area of low elevation along the roadside that collects and pools runoff, and during high flows runs through a culvert beneath a driveway immediately to the east and into a drain inlet that likely connects to the unnamed intermittent drainage beneath the intersection of Adobe Road and Main Street. The Roadside Ditch was saturated with a dominance of hydrophytic vegetation, namely broadleaf cattail (Typha latifolia; OBL) and met all three wetland indicators (Sample Point 1A). A broken water line upslope of the feature is presumed to be the hydrologic source of this aquatic feature. Due to water being present as a temporal result of an artificial source, it is presumed that this location is an artificially created wetland and is therefore not a jurisdictional feature.

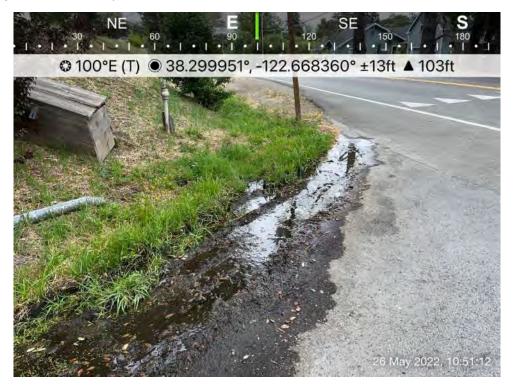
Photograph 2. View of likely broken pipe at entrance to Penngrove Elementary School just east and outside of Study Area on Adobe Road. Broken pipe is presumed to be artificial source of RD-01.

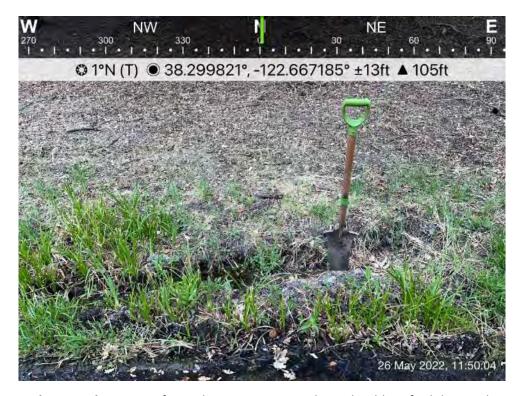
**Photograph 3.** View of Sample Point 2A on northern shoulder of Adobe Road.

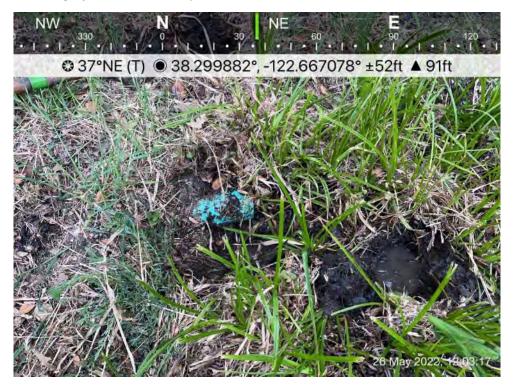
Photograph 4. View of what appears to be a broken pipe at first driveway on Adobe Road west of intersection. Broken pipe is presumed to be artificial source that likely resulted in Sample Point 2A meeting two of three wetland parameters.

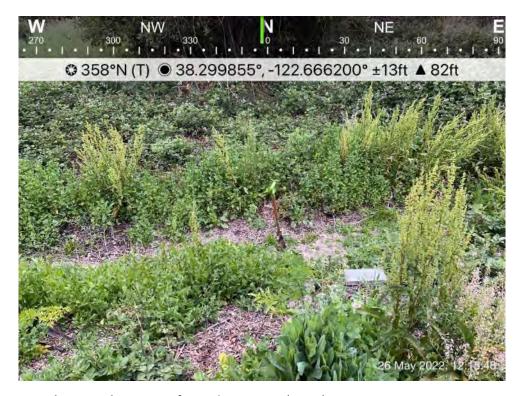
Photograph 5. View of Sample Point 3A (ID-01) in Intermittent Drainage.

One Intermittent Drainage was delineated on the project site (Table 2; Appendices A and B). The Drainage was considered intermittent because: (1) the channel had pooled and flowing water that appeared to be the result of seasonal rains and not perennial hydrology; (2) the channel had significant OHWM indicators such as natural line impressed on the bank, shelving, changes in soil character, presence of litter and debris, and matted and bent vegetation to indicate seasonal flow; and (3) background sources (the NWI, NHD, USGS topographic maps, and other sources) indicated seasonal flow. A sample point (Sample Point 3A; Appendices A and B) taken within the center of the drainage contained a dominance of hydrophytic vegetation, namely fat-hen (FACW). Additionally, the sample point contained primary (surface soil crack [B6], biotic crusts [B12], and oxidized rhizospheres along living roots [C3]) indicators of wetland hydrology and positive soil indications (depleted matrix [F3]). The paired upland sample point (Sample Point 3B; Appendices A and B) was taken in the adjacent low terrace east of the creek channel and lacked all three wetland criteria.

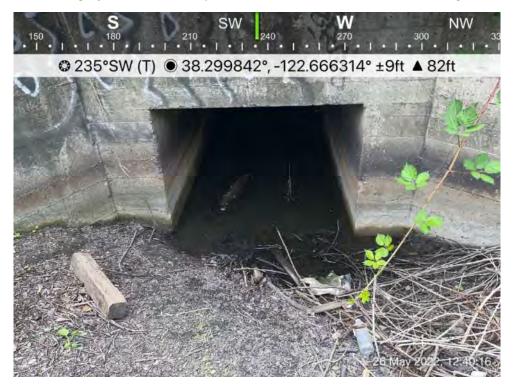
Photograph 6. View of concrete box culvert beneath northeast corner of intersection on (upstream side) of unnamed intermittent drainage.

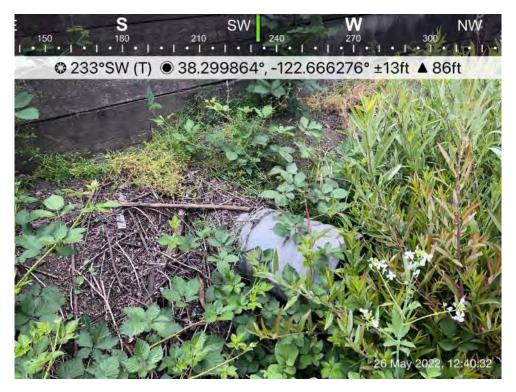
Photograph 7. View of CMP that runs beneath Adobe Road in the northeast corner of intersection that outfalls into unnamed intermittent drainage (ID-01).

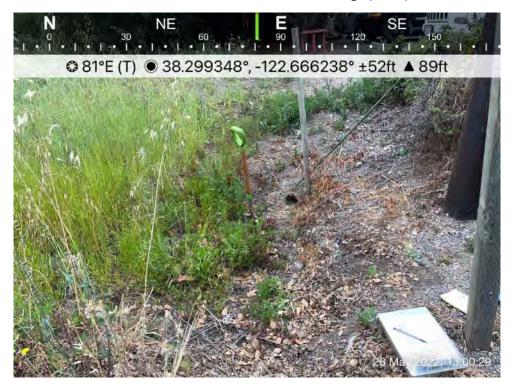
Photograph 8. View of Sample Point 4A on eastern shoulder of Main Street south of the intersection with Adobe Road.
