**Re: California Tiger Salamander Assessment for 304 Todd Road in Santa Rosa, California –
Revised per Updated Site Plan**

GRADING PLAN
 GHILOTTI CONSTRUCTION COMPANY
 APN 134-171-050
 304 TODD ROAD
 CITY OF SANTA ROSA, CALIFORNIA
 MARCH 18, 2021

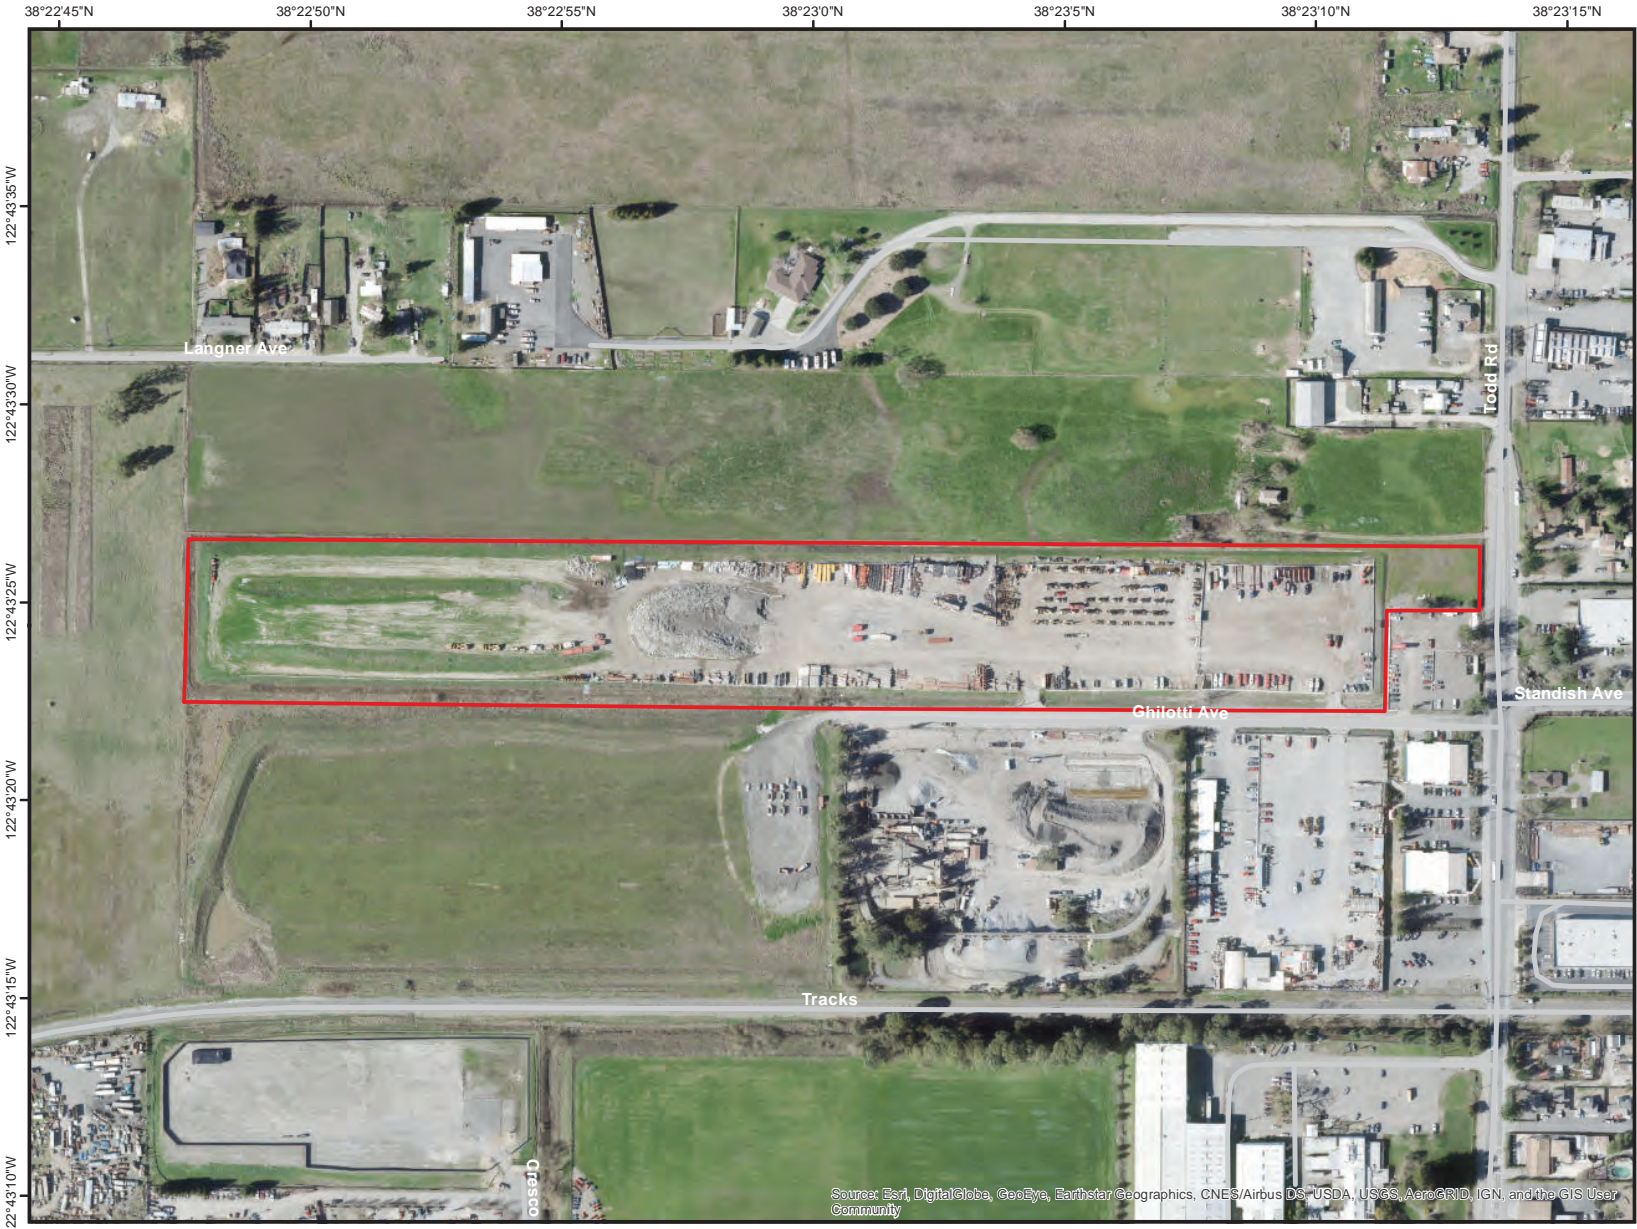
Figure 1. Project Study Area

Project Study Area

304 Todd Road
Santa Rosa, CA

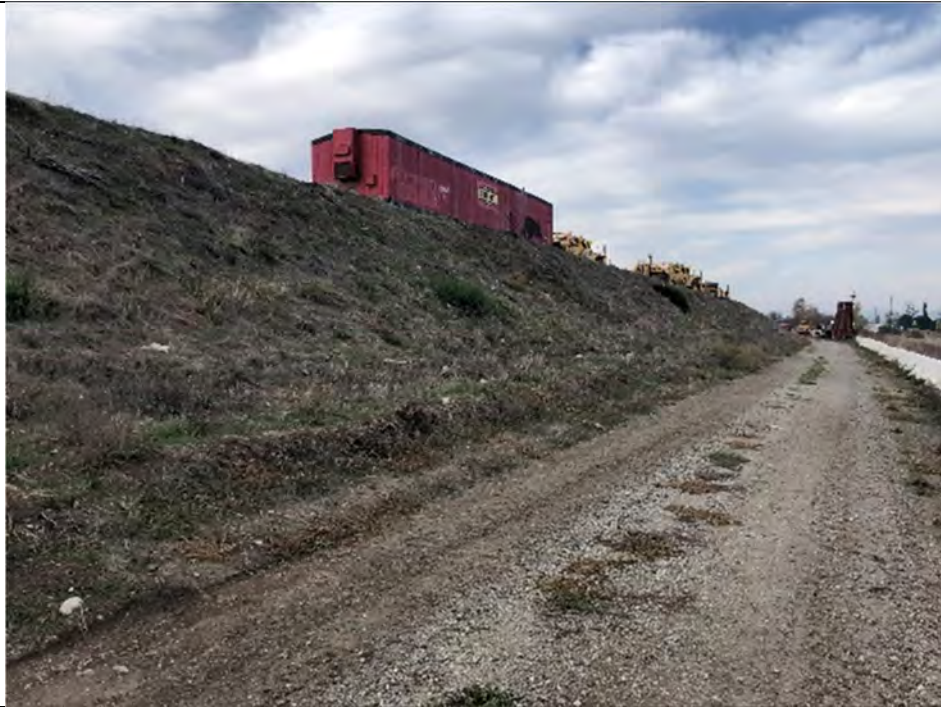
Concrete k-rail (right) prevents CTS from accessing (dispersing onto) the site. Berms are comprised of fill material and do not provide suitable estivation habitat for CTS.

Based on these findings, continued use and/or future modifications as prescribed in the proposed project plan are not likely to impact CTS nor CTS habitats now or in the future and no compensatory mitigation is recommended. Continued maintenance of the on-site k-rail barrier or replacement with a new permanent fence is recommended to ensure avoidance to CTS and nearby CTS habitats.

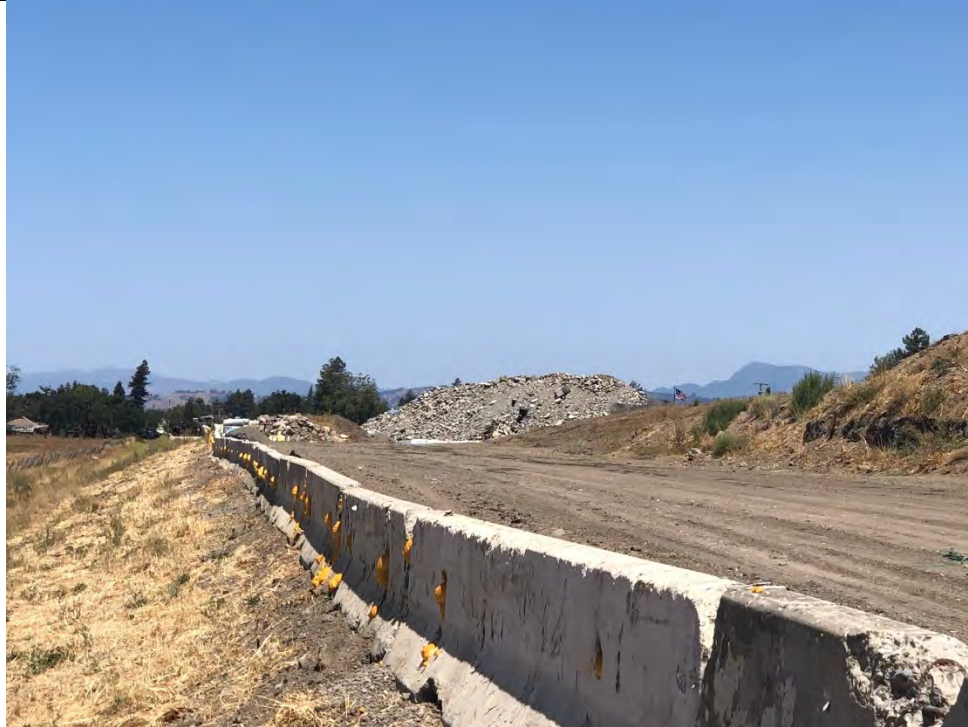
Concrete k-rail is maintained regularly and backfilled on the interior to prevent CTS from dispersing onto site. K-rail also acts a barrier to prevent accidental discharge to adjacent wetlands and drainage ditches (shown on left).

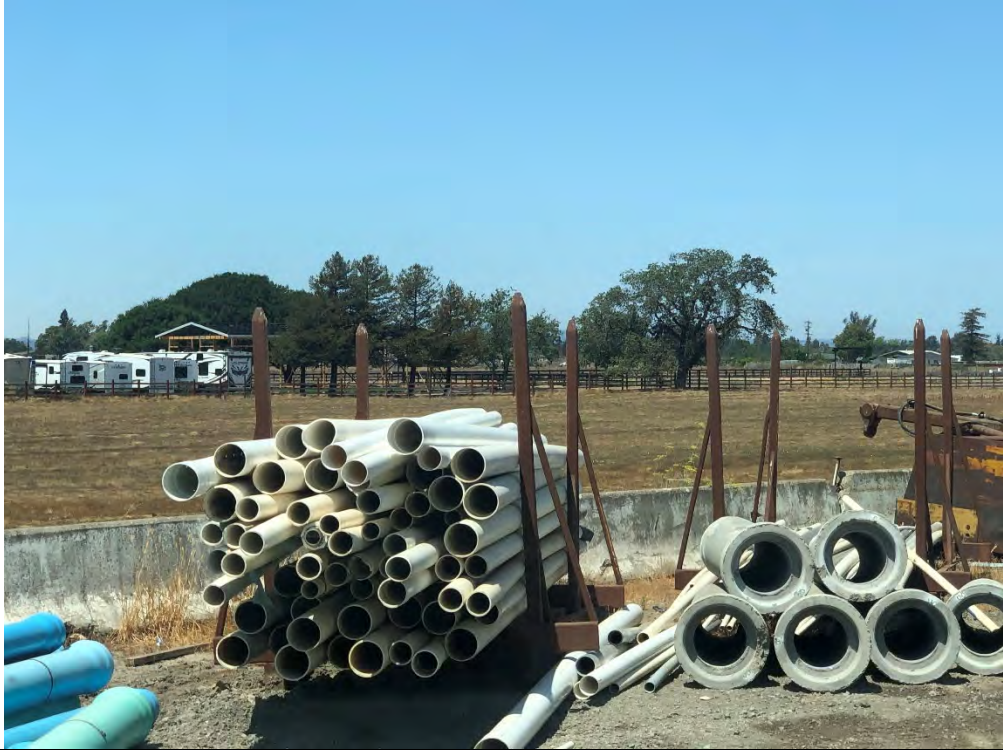
Concrete k-rail prevents CTS from dispersing into stockpile and staging areas on the site.

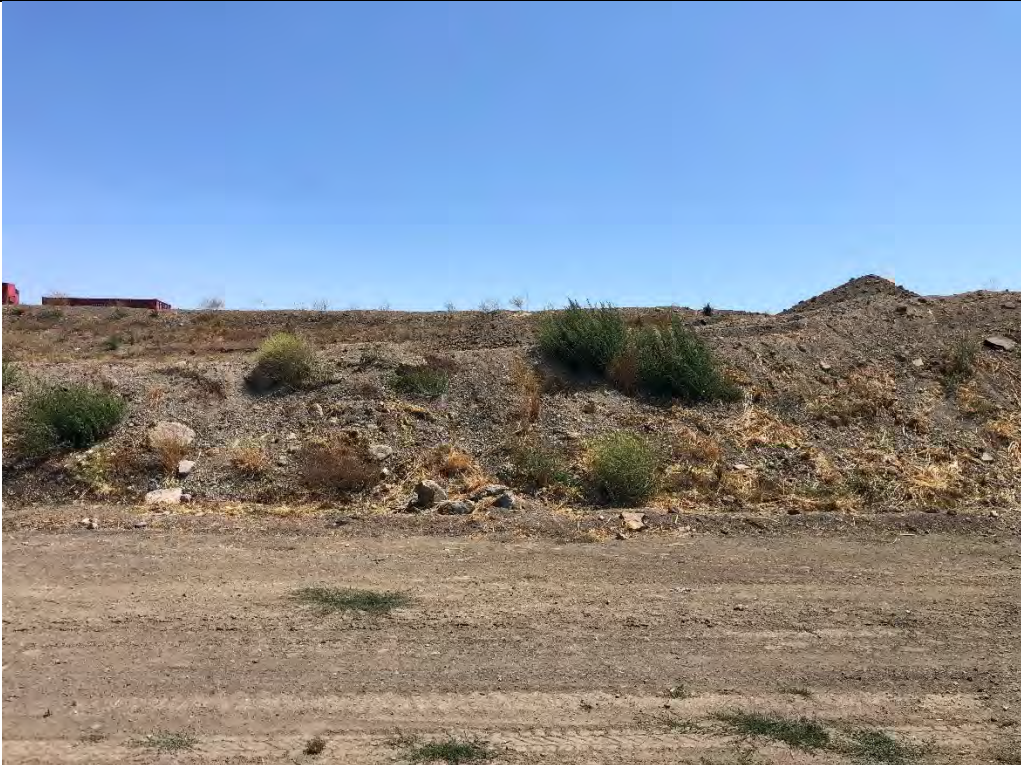
On-site berms are comprised entirely of fill and do not provide suitable estivation habitat for CTS. These areas are covered with a mix of ruderal grass species during portions of the year but remain unsuitable for burrowing animals.

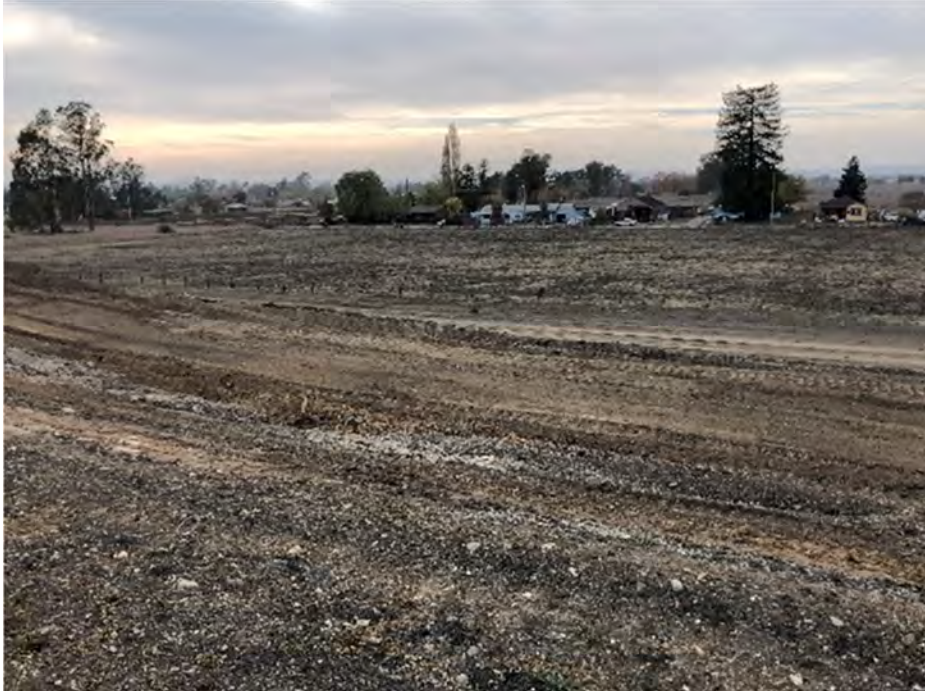
West facing photo taken from top of berm looking out onto dirt roads and adjacent disked agricultural parcel; site compaction and fill precludes CTS.

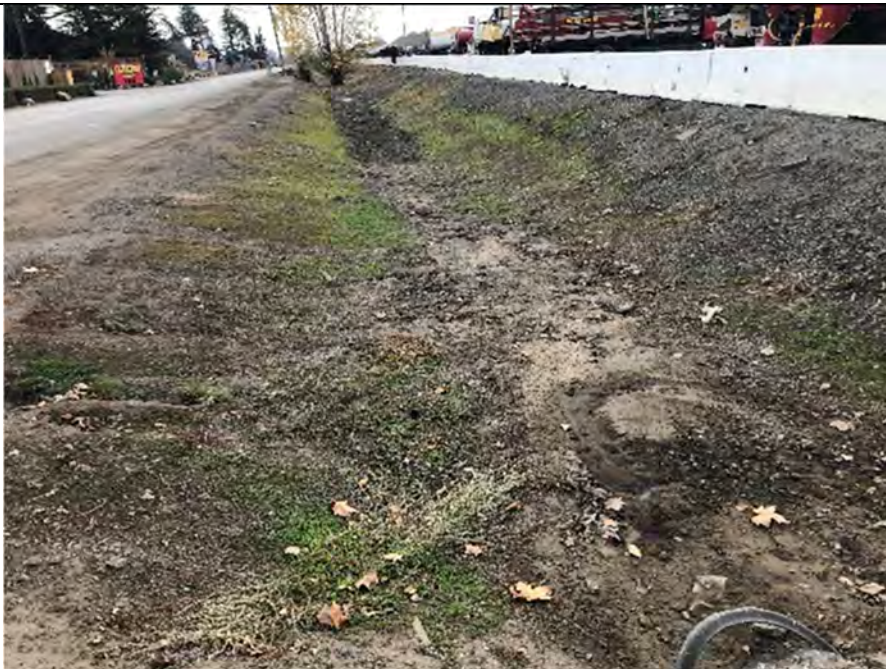
South facing photo of roadside ditch along north east portion of site; feature does not provide suitable breeding habitat except possibly in very wet years. Concrete k-rail (to the right) provides a barrier between this ditch and the project site.
