BODEGA HISTORIC DISTRICT
SURVEY AND DESIGN GUIDELINES
BODEGA, SONOMA COUNTY, CALIFORNIA

MARCH 2012

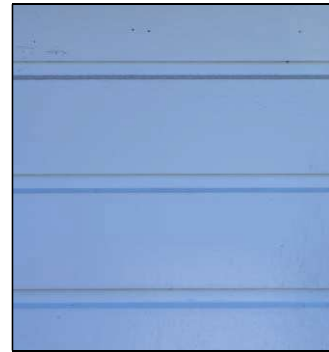
Channel Rustic siding

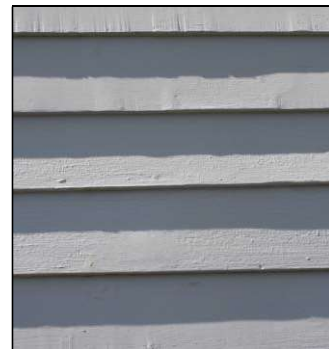
Clapboard siding

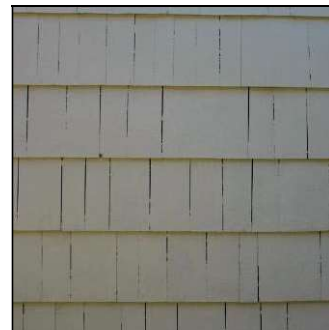
Coursed shingle siding

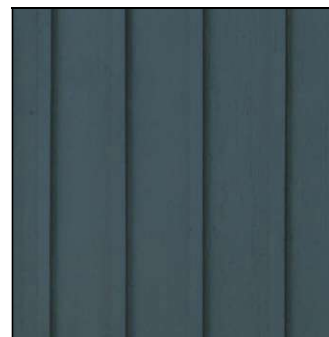
Board-and-batten siding

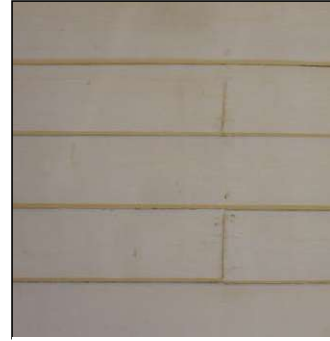
V-groove shiplap siding
